Corrosion analysis on grounding grid used for 220kV electrical equipment

Keywords: 220kV Electrical equipment; Grounding grid; Soil corrosion; Failure analysis.

During the inspection process, maintenance personnel at a certain 220kV substation discovered extensive corrosion damage to the grounding body of electrical equipment, with some copper clad steel strands and grounding flat steel corroded and fractured. The substation has been in operation for 10 years and there are no heavily polluting enterprises nearby. In order to identify the cause of corrosion damage to the grounding body and prevent similar failures from happening again, the author conducted a systematic inspection and analysis of the corroded grounding electrode.

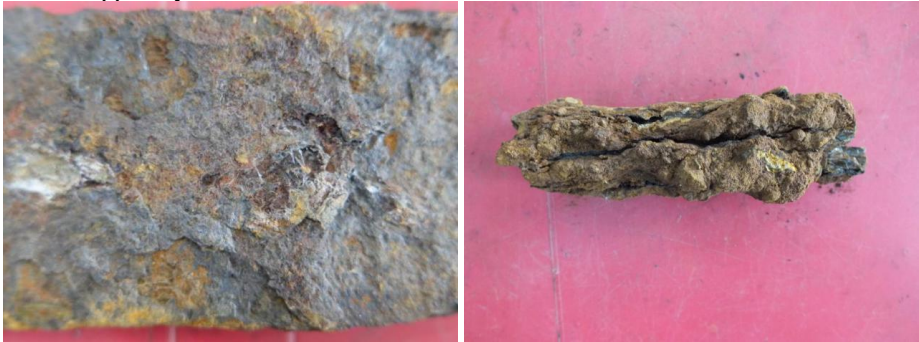
Figure 1 shows the macro morphology of the corroded grounding electrode and it was found that the grounding electrode was severely corroded and damaged. The galvanized layer on the surface of the buried part of the grounding flat steel has completely peeled off and undergone obvious corrosion and fracture, and some areas of the grounding flat steel have been severely softened and perforated. The yellow brown corrosion products are distributed layer by layer on the surface of the grounding electrode, and some of the corrosion products have fallen off without obvious mechanical damage or plastic deformation. Most copper clad steel strands have completely peeled off the copper layer from the steel core, causing severe corrosion of the steel core without copper layer protection. The corrosion products are yellow brown, and some steel cores have completely corroded. In addition, some steel strands with well preserved copper layers have not found obvious corrosion.

(a) Grounding flat steel

(b) Copper clad steel stranded wire

Fig. 1. The macro morphology of the corroded grounding electrode.

Firstly, it is necessary to strengthen the inspection of the electrical equipment grounding grid in the substation nearby the irrigated farmland of the Yellow River, and corroded or broken grounding flat steel and copper clad steel stranded wires should be replaced in a timely manner. The newly replaced grounding flat steel should be coated with hot-dip galvanizing technology for corrosion prevention, and the minimum thickness of the galvanized layer should not be less than 70 μ m and the average thickness is not less than 85 μ m. The substation located in the desert and

irrigated areas could increase the thickness of the galvanized layer of the grounding body to 120 μm due to the strong corrosiveness of the soil. The thickness of the newly replaced stranded wire copper layer should not be less than 0.25mm and the copper layer should not be separated from the steel core, without defects such as cracks, fragments, holes, etc [11,12].

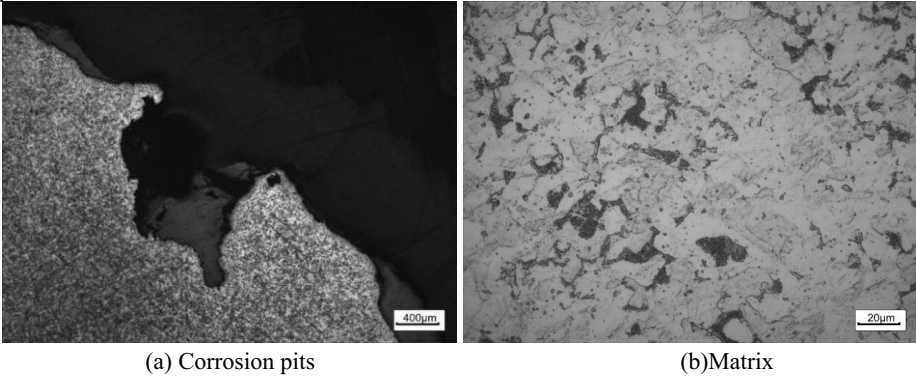
Figure 2 shows the metallographic structure of the corroded grounding flat steel, and it could be clearly seen that the matrix structure of the corroded grounding flat steel was a small amount of banded pearlite and block shaped ferrite, with varying depths

of corrosion pits on the surface. And some of the corrosion holes have penetrated the entire grounding flat steel.

Fig. 2. The metallographic structure of the corroded grounding flat steel.

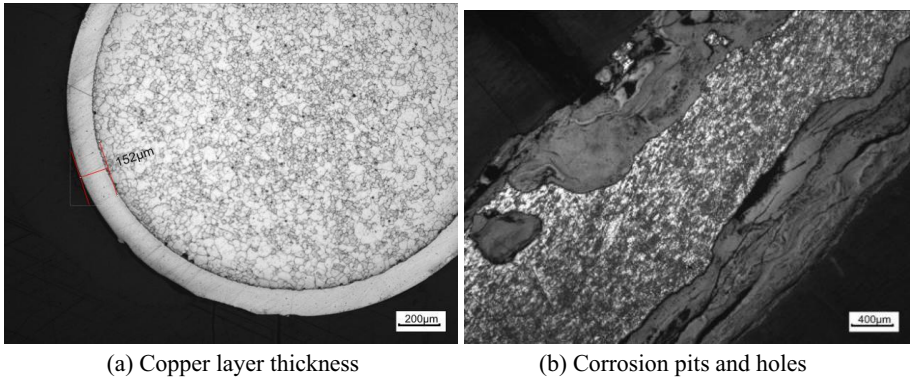
Figure 3 shows the metallographic structure of the corroded copper clad steel stranded wire, and it could be found that the thickness of the copper layer on the corroded copper clad steel stranded wire is about 0.15mm, which is much lower than the standard requirement that the copper layer thickness of stranded wire should not be less than 0.25mm. In addition, the matrix structure of the stranded wire is fibrous martensite with a small amount of ferrite, with a large number of corrosion pits and pores on the surface.

Fig. 3. The metallographic structure of the corroded copper clad steel stranded wire.

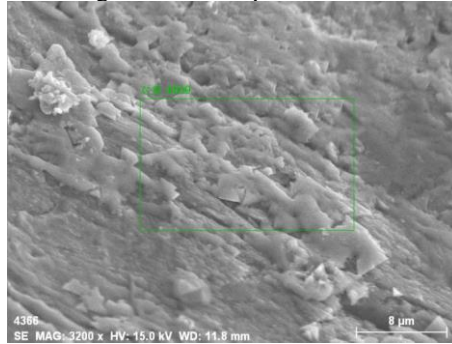
The microstructure and chemical composition of the corrosion products of corroded copper clad steel strands were detected and analyzed using scanning electron microscopy (SEM) and energy dispersive spectroscopy (EDS). Figure 4 shows the SEM morphology of the corrosion product and it could be seen that the corrosion products on the surface of the stranded wire are relatively dense and accompanied by block like particles of different sizes. Figure 5 and Table 1 show the energy spectrum analysis

Fig. 4. The SEM morphology of the corrosion product.

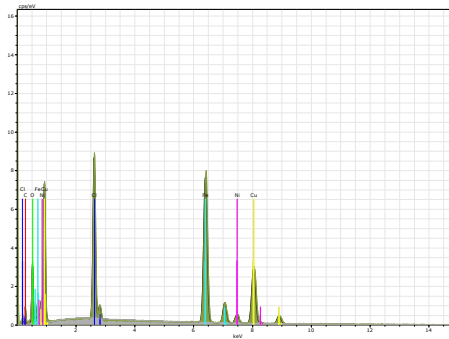
chart and results for corrosion products, and the results indicate that the corrosion products are mainly iron oxides and chlorides. Through analysis, the copper element should be caused by the mixing of corrosion products after the copper layer falls off.

Fig. 5. Energy spectrum analysis chart for corrosion products.
