Analysis of the Structural Characteristics of Rural Residential Buildings in Hainan Province

Keywords: Hainan; township rural houses; seismic performance; sampled detailed inspection of building construction

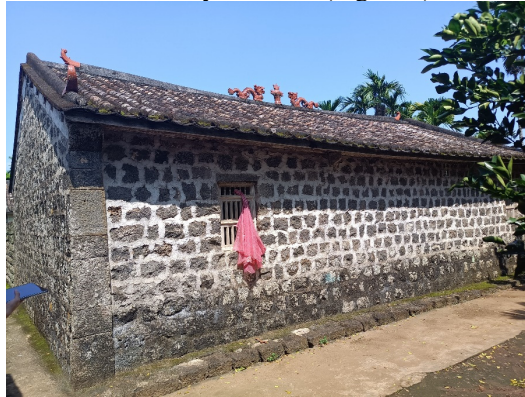
Fig. 8. Stone-wood structure of Hainan Province

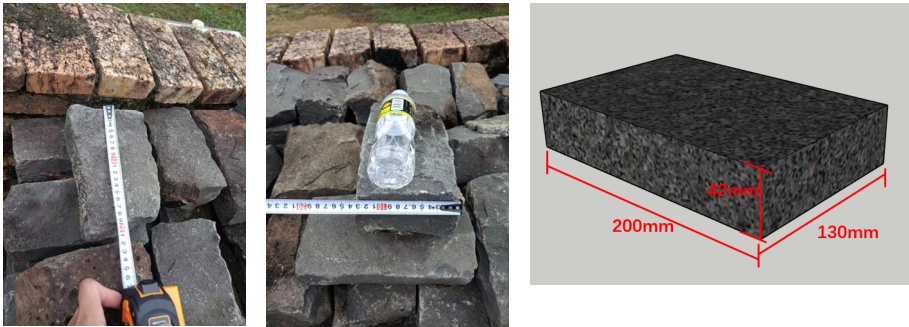
long age and limited by the excavation process. The modulus was measured to be about $200\text{mm} \times 130\text{mm} \times 42\text{mm}$ during the field investigation (Figure 10).

Fig. 10. Stone masonry module in Hainan Province

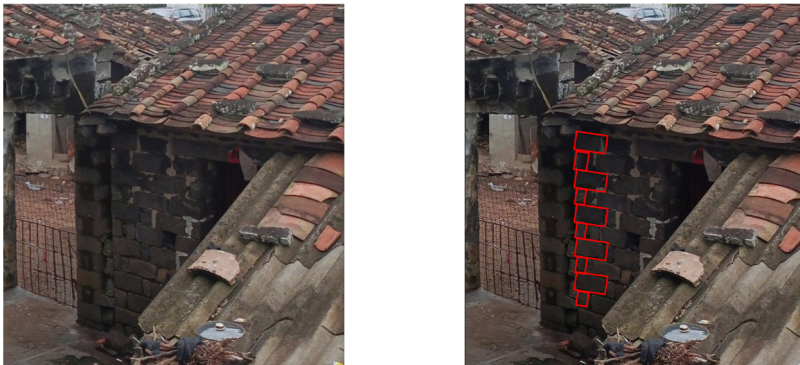
Fig. 11. Schematic diagram of stone-wood structure interlocking masonry in Hainan Province

capacity is very poor. Moreover, the connection between the vertical and horizontal walls is only built by interlocking, and there is no steel bar inside the wall (Figure 11). Therefore, the structural integrity and lateral resistance are poor. The connection between the gable and the roof truss is a purlin-on-wall flush-gabled roof. During the earthquake, the gable is easily destroyed and collapsed. The ash joint of the wall is also easy to crack under the action of the horizontal earthquake, which causes the wall to be damaged.

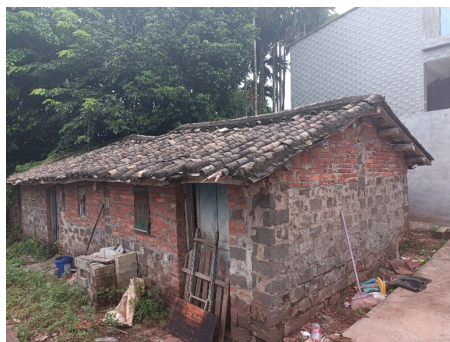
Fig. 13. brick-stone mixed structure in Hainan Province

The masonry materials of brick-stone mixed structures are volcanic stone and sintered clay brick (Figure 13). The modulus of volcanic stone is similar to that of ordinary sintered brick used in recent years, about $240\text{ mm} \times 120\text{ mm} \times 60\text{ mm}$. Often in the lower part of the wall, volcanic stone is the masonry material, and the upper part of the wall uses sintered clay brick as masonry material. Because the gable does not open the window, so the gable is only close to the top of a small part of the use of brick masonry; the longitudinal wall is generally provided with 2 to 4 windows, and the window opening position is located on the brick wall. The window width is 0.5 m and the height is 0.8 m. The depth of the house is about 3m, and the width of the room is from 4m to 10m. Some houses open two doors on the longitudinal wall. The roof is a double-slope roof, and the roof structure is a purlin-on-wall flush-gabled roof. Roof materials use Chinese style tile.

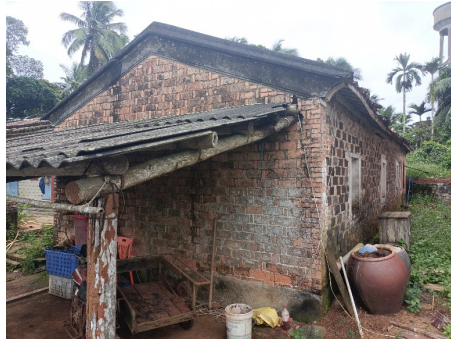
Fig. 14. Brick-wood structure in Hainan Province (cavity wall)

The brick-wood structure is made of sintered clay bricks. The common wall thickness is 180 mm, and there are also cavity walls, as shown in Figure 14. The brick-wood structure also has no windows on its gable wall. There are generally 2 ~ 3 windows on the longitudinal wall, with a window width of 0.5 m and a height of 0.6 m. The roof is a double-slope roof, and the roof structure is a purlin-on-wall flush-gabled roof. Roof materials use Chinese style tile, which is similar to the aforementioned stone and wood structure.

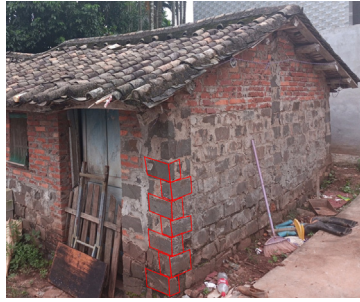
In addition, because the mortar of the brick-stone mixed structure is mixed with red clay and white lime, the strength is low, and it is easy to cause the wall mortar joint to crack under the action of the horizontal earthquake so that the wall is destroyed. The lower wall of the brick-stone mixed structure is stone masonry, and the upper wall is sintered clay brick masonry. The wall has stiffness change at the junction of the two materials. The lack of effective pull-up and low-strength mud will cause the wall to be damaged when subjected to horizontal seismic forces. Taking the Zhangxian M6.6 earthquake in Minxian County, Gansu Province on July 22, 2013 as an example, in the VIII-degree area of the earthquake, the cracks in the wall of the brick and wood structure are developed, and the penetrating and X-type cracks appear in the walls of a few houses, which are seriously damaged [9].

Fig. 15. interlocking masonry of the brick-stone mixed structure

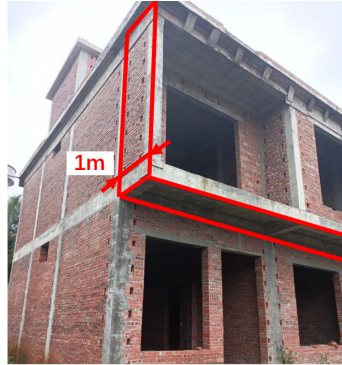
After 2000, most of the brick-concrete structures built in the township areas of Hainan Province were set up with constructional columns and ring beams. Most of the transverse walls and longitudinal walls were connected by steel bars, and the mortar strength was good, which met the requirements of the current seismic code and had a certain seismic capacity. However, compared with the urban area, the houses in the township area are mostly self-built, the number of windows is large and the size of windows is large, and there are irregularities in the plane and elevation, which does not fully meet the specifications, weakens the lateral force resistance of the wall, and makes the seismic capacity of the house decrease. In the survey area, a cantilevered balcony was found on the second floor of a masonry structure under construction. As shown in Figure 17, The cantilevered part is about 1m beyond the facade of the building. When the size and structural connection of the cantilever member do not meet the requirements of the specification, inclined cracks are likely to occur and develop at the end wall of the cantilever beam, resulting in overturning failure.

Fig. 17. A brick-concrete structure under construction in a township of Hainan Province has a cantilevered part on its second floor

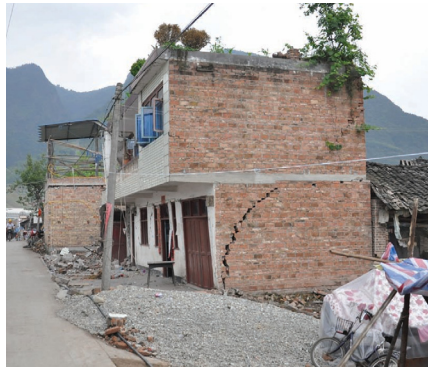
Taking the Lushan M7.0 earthquake as an example, for the structure without columns but with a two-layer cantilever, the stiffness of the upper and lower layers changes obviously. The mass of the second layer is large and the cantilever causes the whole structure to lean forward obviously, which is seriously damaged in the earthquake, as shown in Figure.18 [8].

Fig. 18. A two-story cantilevered brick-concrete structure was damaged in Lushan earthquake.

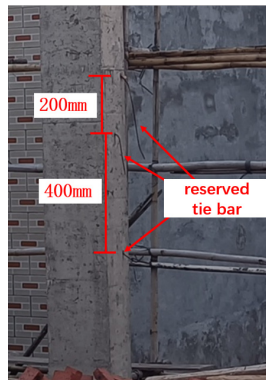
Most frame structures consider seismic fortification in the design and construction, so the frame structure houses built according to the code have better seismic performance. Taking the Lushan 7.0 earthquake as an example, in the area of VIII degree and above, the serious damage of the frame structure is only about 5% [8]. However, in the field investigation, it is still found that there are some residents' self-built frame structure houses under construction, and the number of tie bars reserved for the frame columns does not conform to the specification. In the Lushan earthquake, the failure of masonry-infilled walls of frame structures is still common. The reason is that the local collapse or cracking occurs due to the weak connection between the infilled walls and the beams and columns.

Fig. 20. The number and distance of tie steel bars reserved in frame columns are inconsistent with the code

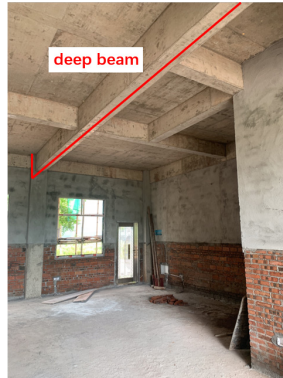
Due to commercial use or other reasons, the bottom layer of the frame structure facing the street in some township areas adopts a large bay and depth, and even removes the frame column in the middle of the bottom layer and adopts the deep beam to transmit the load (Figure 21). This causes the longitudinal deep beam to easily collide with the cross beam during the earthquake and causes the cross beam to be destroyed.

Fig. 21. A frame structure under construction replaces the bottom middle frame column with a deep beam
