Analysis of bulge mechanism of penstock of a hydropower station

Abstract. In this study, the deformation and leakage of pressure steel pipe in a hydropower station were investigated and analyzed. Through calculation and theoretical analysis, it is concluded that due to the failure of the external drainage system, when the internal water extravasation, the external water pressure can not be eliminated in time, resulting in excessive water pressure and deformation of the external steel pipe. As a thin-shell structure, the pressure steel pipe is prone to buckling and instability when subjected to external pressure, and bulging or pipe wall compression often occurs. Stability against external pressure has become an important factor affecting the safety and stability of pressure steel pipes. Therefore, even under normal working conditions, steel pipe without the stiffening ring can meet the external pressure stability, and the design can also consider setting the stiffening ring, because the stiffening ring has a strong ability to resist external pressure.

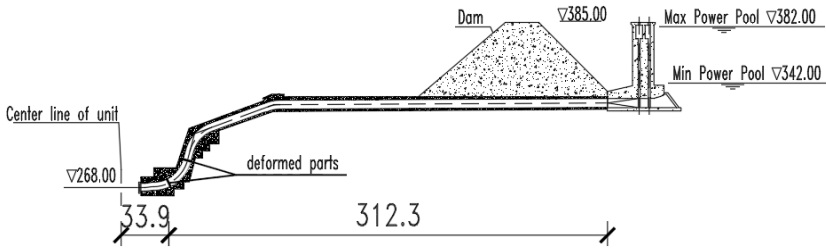
In 2020, the owner found that the steel lining of the penstock near the lower bend bulged into the pipe, as shown in figure 1, and the bulging area accounted for about 80% of the cross-sectional area of the penstock, as shown in figure 2.

Fig. 1. Schematic diagram of the bulge site

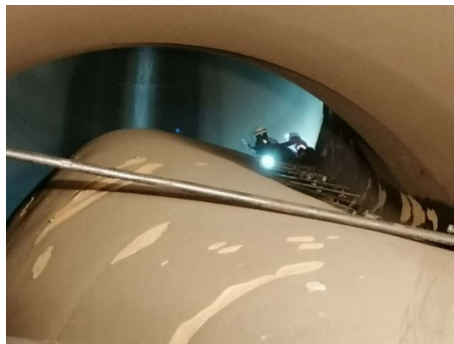
Fig. 2. Steel-lining bulge photos in 2020

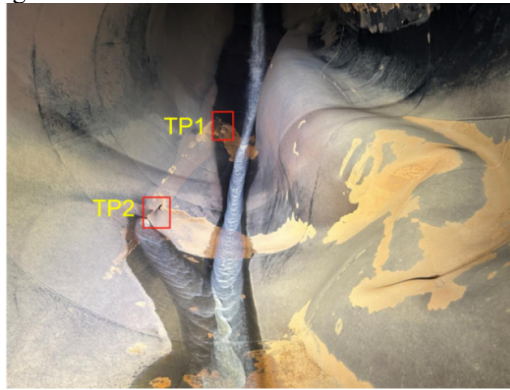
The inward bulging deformation of steel lining has decreased compared to 2020, and the deformation area has been reduced from about 80% in 2020 to about 25%, as shown in figure 3. There are two tear points in the middle of the adjacent pipe section on the right side of the steel lining deformation position (lower left), which are named TP1 (upstream) and TP2 (downstream) in sequence according to the upstream and downstream directions, as shown in figure 3. It was found at the site that there were two obvious water leakage in the penstock, one leaked from the upstream of the penstock with a larger water flow, and the other leaked from the tear point TP2 of the steel lining with a smaller water flow, as shown in figure 3. Right above the penstock deformation and bulging position, the water flow of the discharge has obvious jumps, so it can be judged that there is an obvious stagger phenomenon along the circumferential pipe joint, as shown in figure 4.

Fig. 3. Deformation and tear point location at the lower end of the penstock

The main reason for the instability of the lower bending section of the penstock is the internal water leakage during the operation period, and during the venting process, the excessive external water pressure resulted in the instability of the steel pipe. The inspection found that the penstock had dislocations along the weld, and was also presenting some cracks. In the process of emptying the penstock, the external water pressure cannot be discharged in time due to the failure of the external drainage of the steel pipe, which causes the outer part of the steel pipe to bear excessive external water pressure, resulting in inward deformation. After 2020, during the continuous operation for 3 years, the local weak point of the steel lining was torn under the action of external water pressure. After the tear occurred, on the one hand, the infiltration of internal water intensified and the leakage became more serious and seriously threatening to the safety of the penstock. On the other hand, when the penstock is empty, these torn parts can quickly release the external water pressure, so that the inward deformation of the steel pipe is alleviated, and there is a like recovery under the internal water pressure.

In addition, from the current water leakage situation at the tear point TP2 found during the inspection, the external water in the lower end of the penstock could also come from groundwater or leakage water from a nearby structure, but due to the very low pressure and very small water volume, this could not be the main factor for the external pressure instability of penstock.

When the internal water is leaking out, steel pipe without the stiffening ring can not meet the external pressure stability, and it is necessary to set a stiffening ring to ensure the stability of the tube wall.

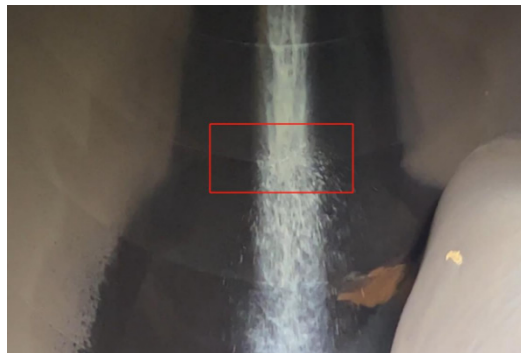
Fig. 4. The staggering of the steel lining weld along the descending pipe section

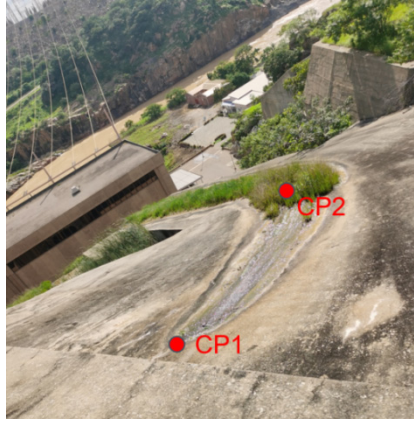
There are obvious leakage points at the upper and middle parts of the inclined penstock section of penstock buried concrete, which is accompanied by the development

of cracks. At present, penstock is empty, and there is still a small flow of water leaking out from the cracks. There are two water leakage points in the inclined penstock section, named CP1 and CP2 respectively, as shown in Figure 5.

Fig. 5. Water leakage points on the outer concrete at the inclined pipe section of penstock
