Analysis of Road Damage with PCI (Pavement Condition Index) Method in Uluwatu Highway

I Wayan Wiraga¹, and Fransiska Moi²

^{1,2} Department of Civil Engineering, Bali State Polytechnic, Bali, Indonesia
wayanwiraga@pnb.ac.id

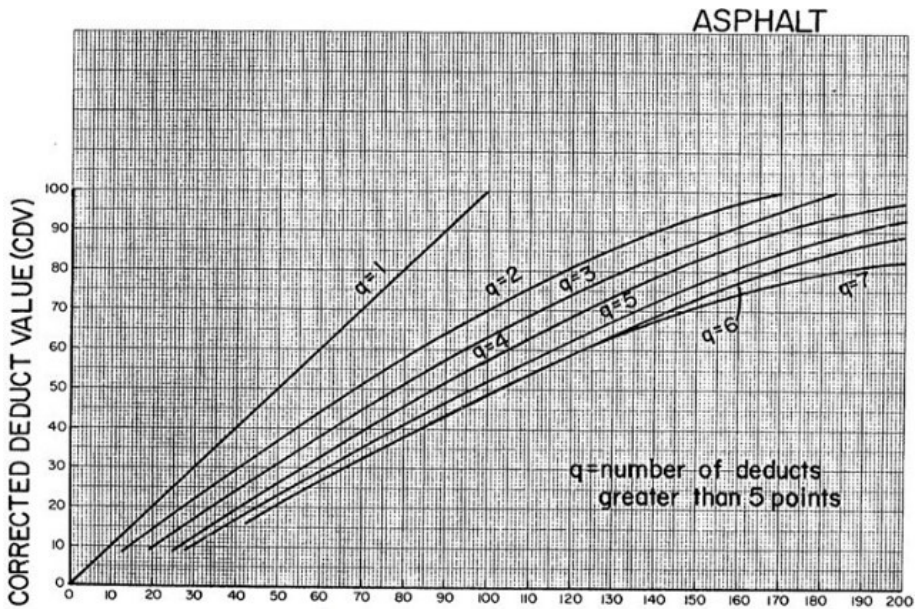
Figure 1. Corrected reduction value

Corrected Reduction Value (CDV). After knowing the nilai TDV (Total Deduct Value) and q (Number of Deducts More than 5 points), then the nilai CDV (Corrected Deduct Value) can be searched by plotting the nilai TDV (Total Deduct Value)

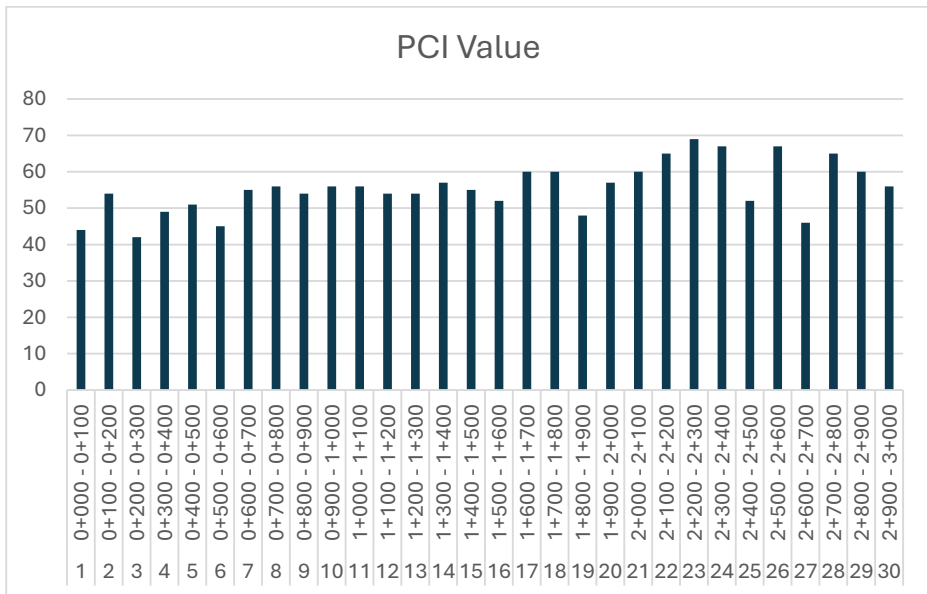
Figure 1. PCI value per segment

Pavement Condition Index (PCI). The PCI value for segment 1 can be calculated as follows: PCI value = 100 - CDV = 100 - 56 = 44. The PCI value on STA 0+000 to STA 0+100 is 44, so the condition of the pavement in segment 1 of Jalan Uluwatu Utara is considered reasonable. The results of the calculation of the PCI value for each segment of North Uluwatu Street can be seen in the following figure.

Based on the results of the calculation of the PCI value in segment I to segment 30, the highest PCI value was found in segment 23, which was 69 (good) while the lowest PCI value was in segment 3 out of 42 (reasonable). The average PCI score of Jalan Uluwatu Utara is 55.5 where the rating is categorized as good. By looking at the results of the analysis of the calculation of the value of the road pavement condition index based on the type and level of severity using the PCI rule, it is necessary to make improvements to improve the condition of the road pavement on the North Uluwatu Road section. Based on the results of the analysis, it is known that for handling pavement damage on the North Uluwatu Highway, it is only necessary to overlay.

The average PCI score of Jalan Raya Uluwatu Utara is 55.5 where the rating is categorized as good. Thus, damage handling is carried out by overlaying to improve the condition of the pavement so that it can serve the traffic load. If the road condition is not immediately repaired and deteriorates, then the costs that will be incurred for repairs and maintenance will be more expensive. In addition, damage that is not handled immediately will have a bad impact on service and also the safety of road users.
