# Fracture Causes of the Al-6Zn-2Cu-1Mg Alloy Transformer Bushing Cover Plate

**Abstract.** Cracking occurred on the aluminum alloy sealing cover of a transformer in a 220kV substation after three years of operation. To investigate the cause, a systematic analysis was conducted on its chemical composition, macroscopic appearance, and microscopic morphology. The results revealed that the sealing cover was made of a 7xxx series aluminum alloy with a composition of Al-6Zn-2Cu-1Mg, which does not comply with the requirements of Q/GDW11717-2023, "Technical Supervision Guidelines for Metal Equipment in Power Grids" (Section 4.4.1 states that "Series 2 and Series 7 aluminum alloys should not be used"), indicating that the material was unqualified. The Al-6Zn-2Cu-1Mg aluminum alloy contains a large number of second-phase particles at the grain boundaries, which have a significant potential difference with the matrix aluminum alloy, leading to a susceptibility to intergranular corrosion. The sealing cover underwent stress corrosion cracking in a stressful and corrosive environment.

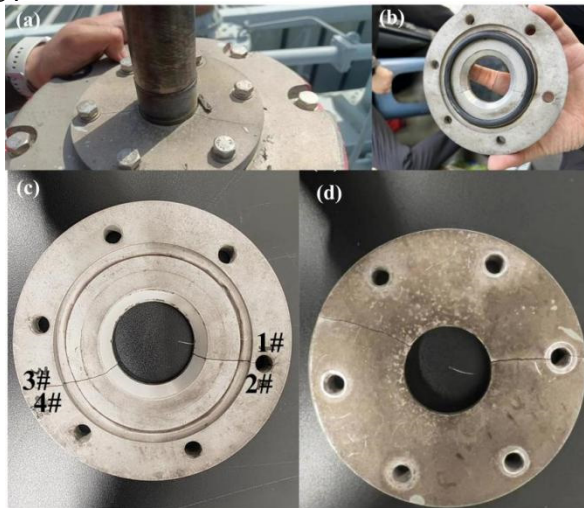
Fig. 1 illustrates the on-site photographs and macroscopic images of the fractured sealing cover. The fracture surfaces consists of two main cracks and can be divide into four sections. Fracture Surfaces 1# and 2# intersect the bolt holes, while Fracture Surfaces 3# and 4# do not. The failed cover exhibits no apparent deformation.

**Fig. 1.** Appearance of fractured sealing cover plate (a)-(b) Failure site, (b)-(d) Fracture Surfaces 1#-4#, from front and back respectively.

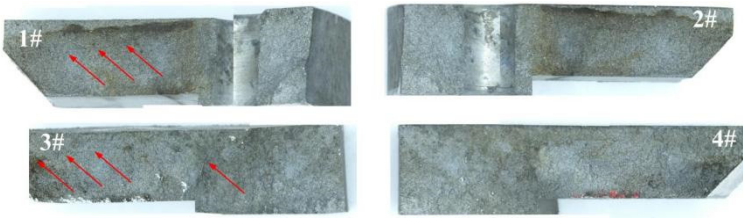
Fig. 2 reveals the fracture morphologies of Fracture Surfaces 1#-4#. Fracture Surfaces 1# and 2#, delineated by the bolt holes, exhibited significant oxidation and contamination at the inner ring position of the annular cover compared to the outer ring position. This trend extended gradually from the inside of the casing upper part towards the outside of the cover, as indicated by the red arrows in Fig. 2. Fracture Surfaces 3# and 4# displayed a consistent trend, with oxidation and contamination intensifying gradually from the outer to the inner regions.

**Fig. 2.** Macroscopic morphology of fracture surface of 1#-4#.

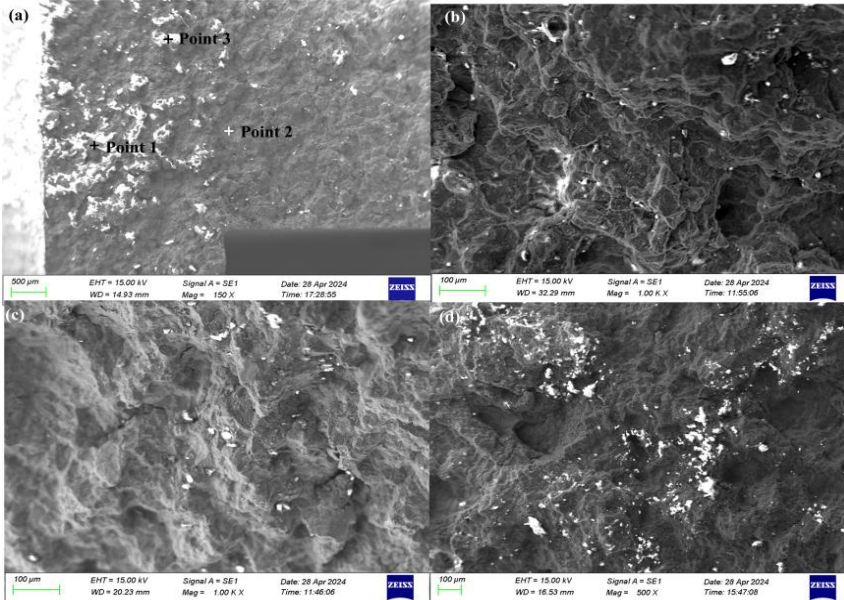
Fig. 3 shows the microstructural analyses of the fracture surface. The fracture surface exhibited virtually no dimples, and numerous casting defects such as microcracks and pores were visible internally, indicative of typical brittle fracture characteristics. In some areas, the fracture surface was coated with a layer of oxides, and energy dispersive spectrometry (EDS) results in Table 2 showed high concentrations of C, O, and S elements on the fracture, suggesting oxidation and contamination as the causes.

**Fig. 3.** (a)-(d) are the microscopic morphology of fracture surface at different locations.

Chemical element	Composition(wt%)				
	C	O	Al	Zn	S
Point 1	30.11	19.74	30.82	3.66	0.61
Point 2	42.20	26.30	2.36	/	0.07

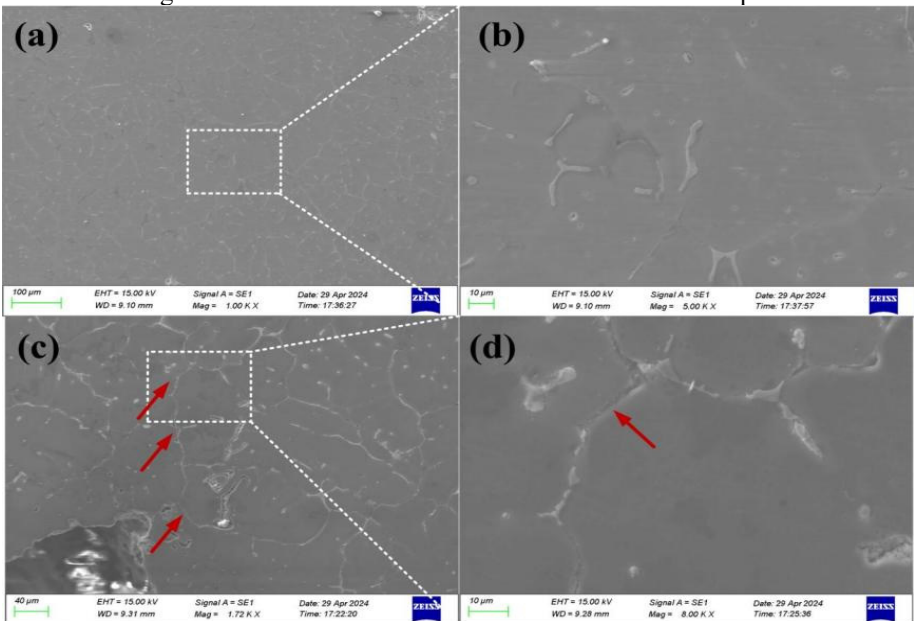
After sectioning the side of fracture surface 4# to prepare a metallographic sample, microstructural morphology and compositional analyses were conducted on the areas near the fracture. The results are presented in Figures 4-8. Fig. 4 compares the morphologies near and far from the fracture, with Fig. 4a and Fig. 4c showing the microstructures away from and near the fracture, respectively, and Fig. 4b and Fig. 4d being magnified views of Fig. 4a and Fig. 4c. From Fig. 4a-b, it is evident that the second phase is primarily distributed along the grain boundaries in a network-like pattern, with a small amount of spherical second phase present in the central regions of the crystals. No obvious microcracks are observed within the grain boundaries or interiors. Fig. 4c-d reveal that cracks propagate from the fracture along the grain boundaries into the crystal interior, as indicated by the red arrows. The distribution of cracks is more pronounced at the grain boundaries and at the interfaces with the second phase.

**Fig. 4.** Microstructure of sealing cover plate (a) away from the fracture surface and (c) near the fracture surface, (b) and (d) are the local enlarged drawing of (a) and (c).

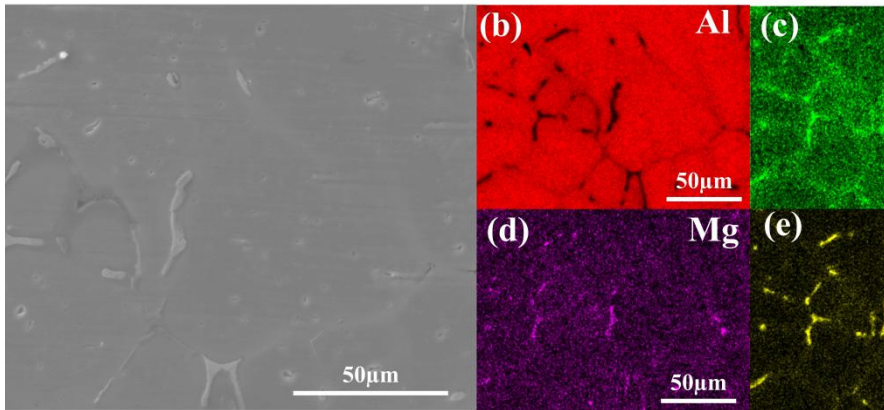
Figs. 5 and 6 present the surface scanning energy dispersive spectroscopy (EDS) maps of Figs 4b and 6d, respectively. It is evident from these figures that the phases in

the crystalline structure away from the fracture are primarily the second phase containing Zn, Mg, and Cu, with no significant segregation of elements such as C, S, and O observed. However, scanning near the fracture in Fig. 6 reveals a notable segregation of C and O elements near grain boundaries and the second phase, located at the crack propagation sites. This demonstrates that C and O elements progressively penetrate into the sample along the cracks, resulting in significant intergranular corrosion. On one hand, the larger atomic misarrangement at grain boundaries facilitates the migration of corrosive substances such as C and O into the sample along these boundaries. On the other hand, the significant potential difference between the second phase and the aluminum matrix leads to accelerated corrosion at grain boundaries, thereby forming corrosion cracks that propagate along these boundaries.

**Fig. 5.** (a) Microscopic morphology and (b)-(e) scanning energy spectrum of Al, Zn, Mg and Cu, of the surface in Fig. 4a, respectively.

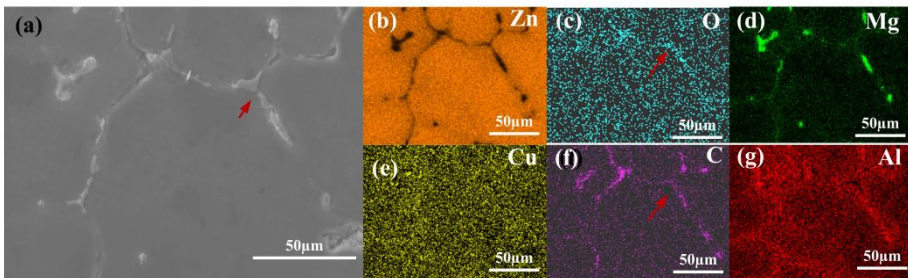
**Fig. 6.** (a) Microscopic morphology and (b)-(g) scanning energy spectrum of Zn, O, Mg, Cu, C and Al near the fracture surface in Fig. 4c, respectively.

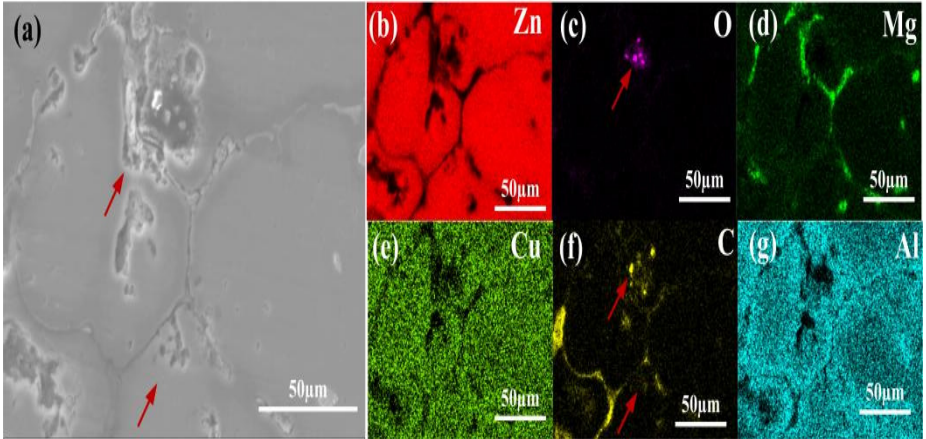
Figs. 7-8 present the energy dispersive spectroscopy (EDS) maps of the microstructure near the fracture surface. Fig. 7 reveals that corrosion gradually progresses within the crystal grains besides grain boundaries, as indicated by the red arrows. The element C can be detected within the crystal grains. Fig. 8 indicates the presence of sulfur-containing corrosive substances near the fracture, in addition to oxides.

**Fig. 7.** (a) Microstructure and (b)-(g) scanning energy spectrum of Zn, O, Mg, Cu, C and Al near the fracture surface, respectively.

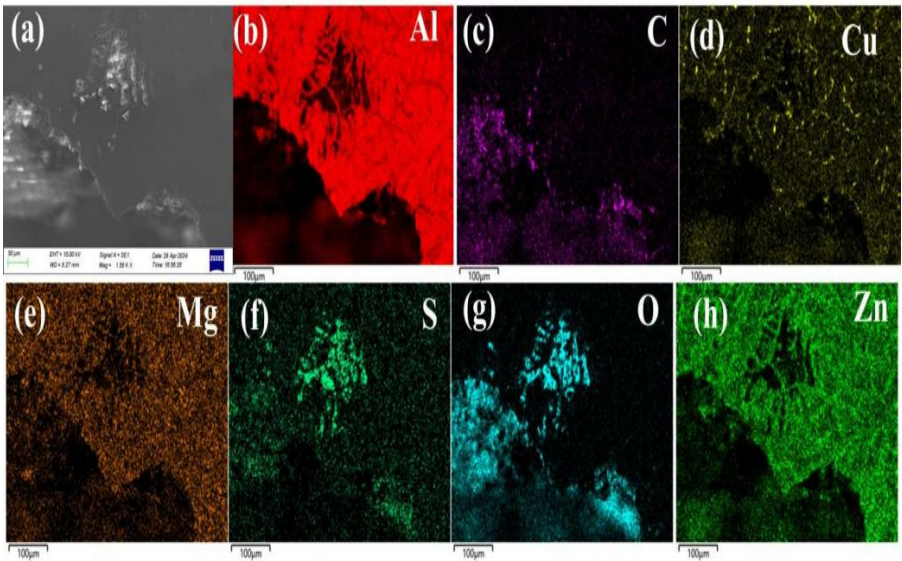
**Fig. 8.** (a) Microstructure and (b)-(h) scanning energy spectrum of Al, C, Cu, Mg, S, O and Zn near the fracture surface, respectively.

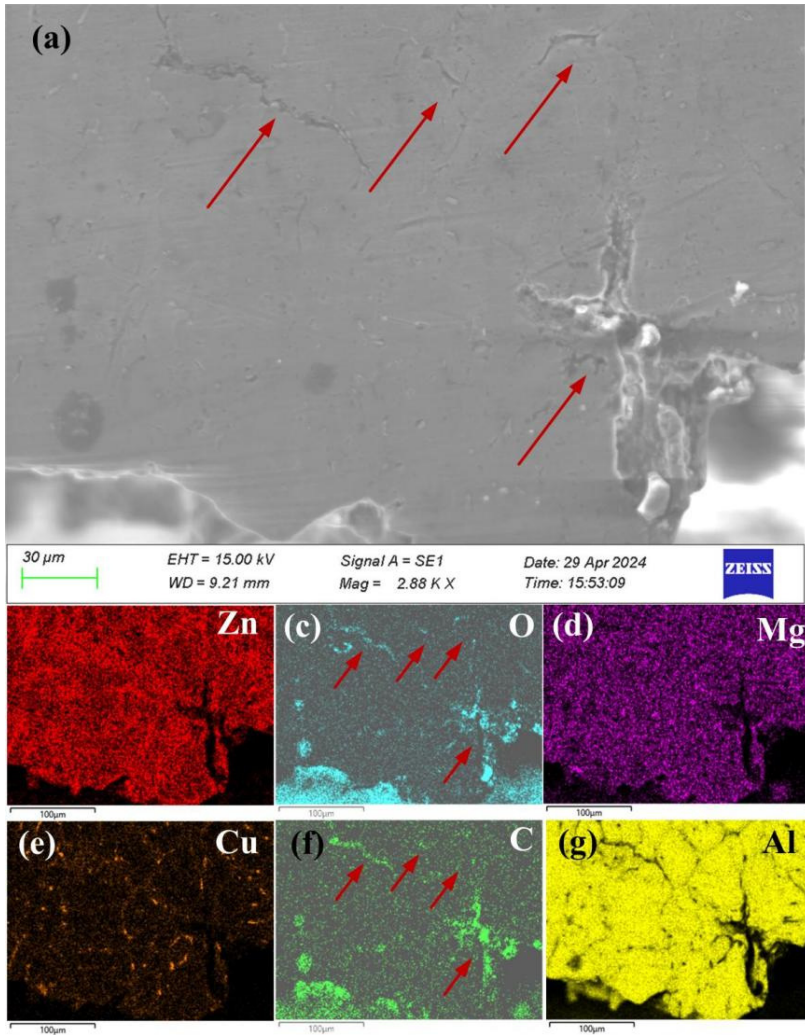
Fig. 9 illustrates the propagation of corrosion cracks in the vicinity of the fracture surface. It is evident from the figure that the cracks gradually extend from the fracture surface to a distance of 300-400 μm, with significant segregation of C and O elements at the crack locations.

**Fig. 9.** (a) Microstructure and (b)-(g) scanning energy spectrum of Zn, O, Mg, Cu, C and Al near the fracture surface, respectively.
