The preliminary study of diagnosis techniques for the building defects with damp by infrared thermography

Longyu Wan^{1, a} and Zukang Lei^{2, b *}

¹School of Architecture and Urban Planning, Huazhong University of Science and Technology 430074, Wuhan, Hubei, China.

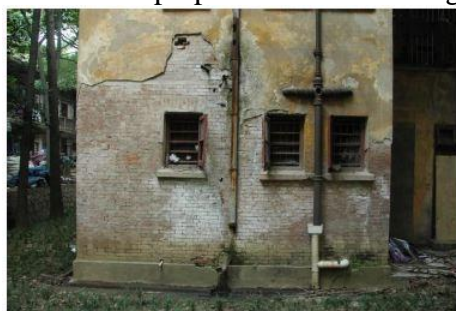
Fig. 1.
Visible light image.

The object of this study is a brick wall in Huazhong University of Science and Technology, Wuhan, Hubei, China. It belongs to the teachers' estate built in 1960s and has been suffering from serious housing defects over these years. As the wall is surrounded by trees, there is not enough lighting, then mould and moisture grows. (Fig. 1)

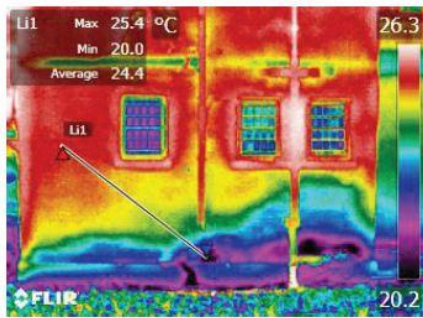
Fig. 8.

An example of analyzing wall surface temperature gradient from thermal image containing various defects. A line measurement in thermogram which represents the most typical defects on surface was exported to csv file (Fig. 8). As seen from Fig. 9 three kinds of defects can be figured out (but there is some overlap on the curve) according to their gradients:

Efflorescence. Its temperature ranges from 23.9 °C to 25.4 °C, and its gradient, ratio of surface temperature change and number of measure points is 0.028.

Rising damp. Its temperature ranges from 20.0 °C to 24.5 °C, and its gradient is 0.15.

Mould growth. Its temperature ranges from 20.0 °C to 23.0 °C, its gradient is 0.3.
