# Experimental Study on Long-Term Working Performance of Reinforced Material for Crushed Stone

**Keywords:** Gravel structure; Reinforcement material; Long-term strength; Construction damage; Creep; aging

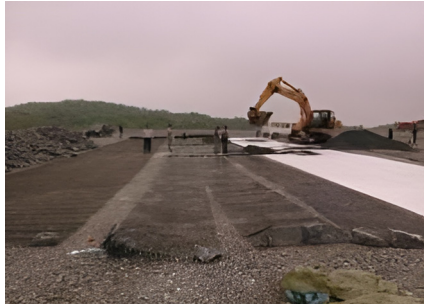
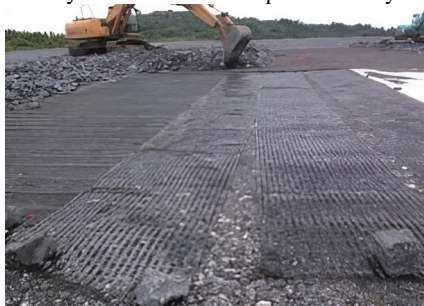
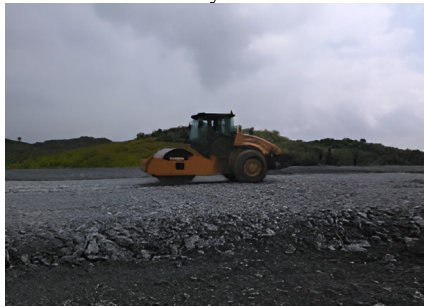
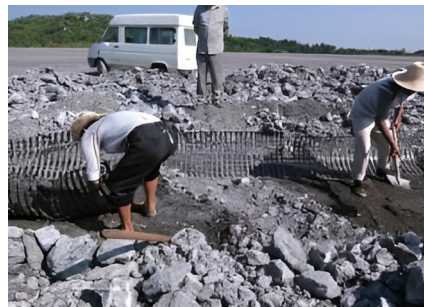
**Fig. 2.** Picture of reinforcement failure test site

a. Lay reinforcement and protective layer

b. Lay filler

c. Crush

d. Dig the reinforcement

According to the results of field rolling test, the solid volume ratio can reach 79% by using 26t roller for 4 times of static rolling and 8 times of vibration rolling. On this basis, construction damage tests of three kinds of reinforcement were carried out under three working conditions: no protective layer, 5cm thick protective layer on the reinforcement, and 5cm thick protective layer on both the top and bottom of the reinforcement. A total of 9 groups of field full-size tests were carried out, and the size of the test site for each group was 22m×34m. Table 2 is the number of test sites, and Figure 2 is the picture of field tests.

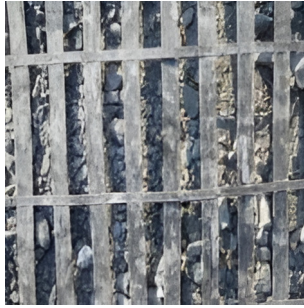
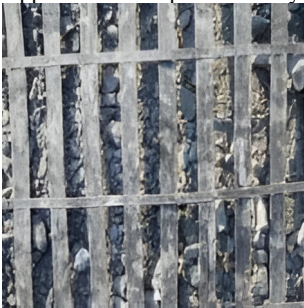
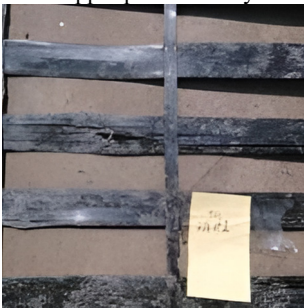
**Fig. 4.** PET grid sample diagram

Figure. 4 shows the samples excavated after the filling construction of PET180 grid. Figure. a shows that there are protective layers above and below the reinforcement in zone A3, and the samples have a small amount of ordinary wear. Figure b shows that the upper part of the reinforcement in zone A2 is protected. The sample is mainly characterized by ordinary wear and splitting, with occasional blunt trauma. Figure. c shows that the reinforcement in area A1 has no protective layer, and the

samples are mainly split, with serious common damage and blunt trauma. No severing damage was observed in the three tests.

a. Upper and lower protective layers

b. Upper protective layer

c. No protective layer

From Figure. 4 to Figure. 6, it can be seen that the three kinds of reinforcement materials, PET180, HPDE150 and PET200, have the most serious damage when there is no protective layer. The protective layer of medium and coarse sand with a thickness of 5cm on top can reduce the apparent damage of construction, and the protective layer of coarse sand with a thickness of 5cm on top and bottom can significantly reduce the apparent damage of construction.

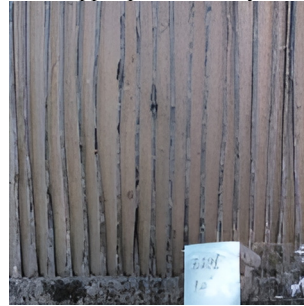
**Fig. 5.** HDPE grid sample diagram

Figure. 5 shows the samples dug after the HDPE150 geograde filling construction. Figure. a shows that both the upper and lower reinforcement in zone B3 are protected, and the samples are mainly worn with occasional blunt trauma. Figure b shows that the upper part of the reinforcement in zone B2 is protected. The sample is mainly characterized by ordinary wear and splitting, with occasional blunt trauma. Figure. c shows that there is no protective layer for the reinforcement in area B1, and the samples are mainly common wear and blunt damage, with occasional splitting. No cutting damage was found in the three regional grid tests.

a. Upper and lower protective layers

b. Upper protective layer

c. No protective layer

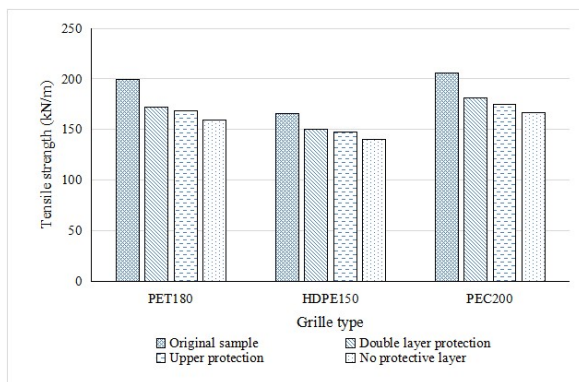
**Fig. 7.** Average tensile strength of grilles under different working conditions

It can be seen from Table 3, Figure 7 and Figure 8 that:

1) The tensile strength of the original reinforcement exceeded the nominal tensile strength, and the average measured tensile strength of PET180 was 199.22kN/m, exceeding 10.7%; The average measured value of HDPE150 is 165.40kN/m, exceeding 10.3%. The measured mean value of PEC200 is 205.92kN/m, exceeding 2.9%.

2) The average maximum elongation of the original PET180 grille is 9.3%, which is reduced to 7.5% after rolling, a decrease of 19.1%; The average maximum extension rate of the original HDPE150 grille is 14.5%, and it is reduced to 12.8% after rolling, which is reduced by 11.1%. The average maximum elongation rate of PEC200 geotextile is 12.7%, which is increased to 13.4% after rolling, an increase of 5.4%.

4) After rolling, the tensile strength of the reinforcement with a 5cm thick medium coarse sand protective layer above and below is slightly greater than that with only a 5cm thick medium coarse sand protective layer on the top of the reinforcement, and the values of the two are close, which is related to the rolling of the fill under the reinforcement; However, when there is no protective layer, the strength of the reinforcement decreases greatly, indicating that the protective layer on the reinforcement has a great influence on the strength.

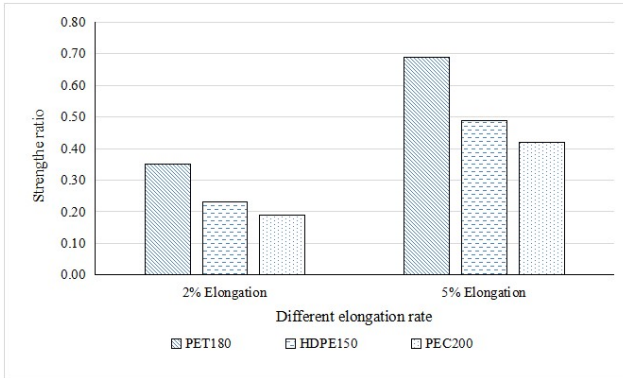
**Fig. 8.** Strength ratios of different elongation rates

3) When the elongation rate is 2%, the tensile strength of PET180 grille is 35% of the maximum tensile strength, HDPE150 is 23%, and PEC200 is 19%; When the elongation rate is 5%, the tensile strength of PET180 grille is 69% of the maximum tensile strength, HDPE150 is 49%, PEC200 is 42%. It shows that the elongation of PET is small and the strength increases rapidly, but the test data are discrete and the strength stability is slightly poor. The elongation of PEC is too large and the strength increases slowly. In contrast, the strength and elongation of HDPE are in the middle, and the test parameters are stable, which may also be the reason why high-density polyethylene is used in China.

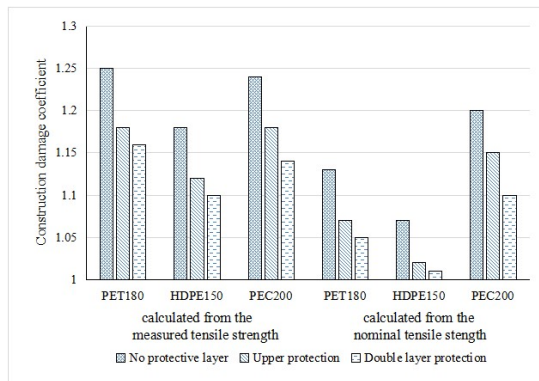
Figure. 9 shows the comparison of construction damage coefficients of PET180, HDPE150 and PEC200 grilles under three working conditions: upper protective layer, double protective layer and no protective layer.  $RF_{ID1}$  is the construction damage coefficient calculated from the measured tensile strength.  $RF_{ID2}$  is the construction damage coefficient calculated from the nominal tensile strength of reinforcement, which is used when the test data is lacking.

**Fig. 9.** Average construction damage coefficient of reinforcement under different working conditions

As can be seen from Figure 9:

1) The damage coefficient of PET180, HDPE150 and PEC200 is 1.25, 1.18 and 1.24 when no protective layer is installed. After the protective layer is installed, the construction damage coefficient is obviously reduced.

2) The construction damage coefficient of the grating under the two working conditions of PET and HDPE with a protective layer and a protective layer above and below is relatively close, the main reason is that before laying the reinforcement, the lower filler has been rolled and compacted, the filling surface is relatively flat, and there is no obvious edge and corner, so the lower filler has less damage to the grating. There is a great difference in the construction damage coefficient of the grating under two working conditions of PEC with protective layer on top and both on top.

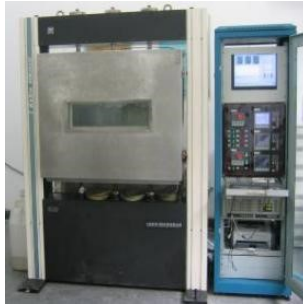
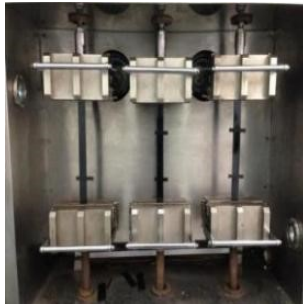
**Fig. 10.** Microcomputer-controlled electronic creep endurance testing machine

a. Schematic diagram of the whole machine

b. Grid sample in the environment

RDW20030 electronic creep endurance testing machine and microcomputer controlled electronic universal (tensile) testing machine CMT4305 were used in this test. The test equipment is shown in Figure 10 below. The load level adopts 3 levels of load, respectively using the ultimate load of 40%, 45% and 45%.
