Research and Application of Leakage Control Technology for the Secant Pile Waterproofing Curtain in Complex Environments

2 Project Overview

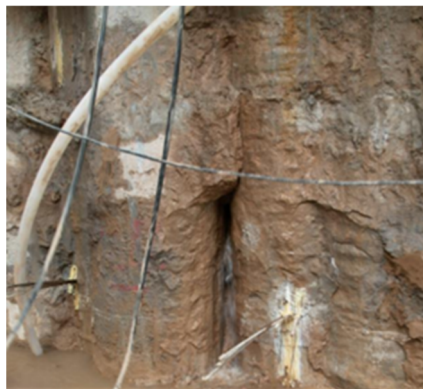
(1) Leakage between interlocking piles

The leakage of water between the interlocking piles on the construction site is mostly caused by the inclination of the interlocking pile body, resulting in insufficient overlap length between the plain pile and the reinforced concrete pile, and the overall pile body is in a "forked" phenomenon. The leakage between the interlocking piles is shown in Figure 2. This phenomenon is mostly located deep in the geological strata, extending all the way to the bottom of the column. This phenomenon has a large water inflow and makes it difficult to seal the leak. There are three main reasons for the leakage between interlocking piles. Firstly, the verticality of the mechanical drill rod does not meet the standard, resulting in a large vertical deviation of the pile body, and the deeper the geological depth, the greater the deviation of the pile body; Secondly, due to inaccurate positioning of the pile body, the interlocking depth between the plain pile and the reinforced concrete pile does not meet the requirements; The third reason is that the construction interval between adjacent piles exceeds the preset time due to materials, machinery, climate, and other factors. When reinforced concrete construction is carried out, the curing strength of the plain piles is too high, and the pile body deviates towards the soil side, resulting in insufficient interlocking between the reinforced concrete piles and the plain piles, and even inability to overlap.

Fig. 2. Water seepage between interlocking piles

(1) For the leakage point at the opening of the foundation pit, heavy loading is applied at the opening, and recycled cotton is filled into the internal space of the opening. A grouting rig is used for post pile grouting to seal the leakage. After the sealing is completed, slurry is used for reinforcement grouting.

(2) The high split part of the interlocking pile is reinforced by planting steel bars and hanging steel mesh and spraying concrete to prevent the soil behind the split from being washed out with water.

(3) In areas where there are many “forks” in the interlocking piles, a grouting rig is used to vertically inject deep holes into the inner side of the foundation pit close to the supporting piles. The grouting reinforcement depth is 15m to compensate for the loss of water stop curtain length caused by the “forks” of the interlocking piles, and to increase the seepage path of groundwater from outside the foundation pit into the foundation pit. At the same time, a grout-ing rig was used to inject grout diagonally at a depth of about 8.0m at the “fork” leakage point of the blocked interlocking pile, with a post pile inclination of 30-45 °. Pre grouting reinforcement was carried out on the soil behind the pile at the "fork" point of the interlocking pile.

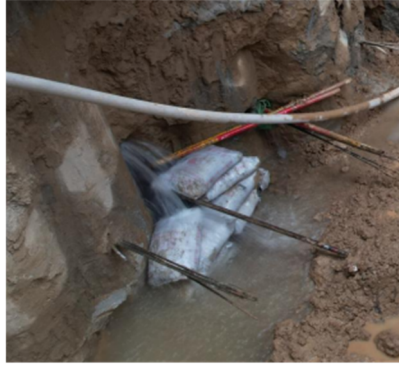
(2) Anchor hole leakage

Due to the shallow burial depth of the groundwater level in the construction area, the liquid index of the loess layer located below the groundwater level is 0.84, which is in a soft plastic and locally flowing plastic state, and is highly prone to consolidation deformation due to groundwater loss. The leakage of anchor holes in the foundation pit is shown in Figure 3. When the rotary jet anchor cable is installed below the groundwater level, the drill rod penetrates the water stop curtain behind the interlocking pile. Under the action of water pressure, a large number of soil particles mixed with groundwater flow out from the hole, causing a large amount of soil loss outside the foundation pit and significant geological settlement deformation, seriously threatening the safety of the foundation pit and surrounding environment.

Fig. 3. Anchor Cable Hole Leakage

(1) After the completion of the pile formation by the rotary jet grouting anchor, the flexible permeable materials (such as geotextiles, burlap bags, black cot-ton, etc.) and the water guide pipe are immediately pushed into the rotary jet grouting anchor hole using the anchor drill bit, exerting the filtering effect of the flexible permeable materials, preventing the loss of cement slurry and sand in the anchor hole, and achieving the guidance and drainage of water seepage in the anchor hole.

(2) Based on the experience of plugging in neighboring projects, two sealing and plugging schemes are developed for the leakage of water in this project. 1、Cement+water glass dual liquid slurry sealing and plugging scheme. When using cement+water glass double liquid slurry for sealing, the pressure of the grouting slurry directly acts on the outer side of the biting pile wall, causing horizontal deformation of the support pile inclined towards the inner side of the foundation pit, which has an adverse impact on the stability of the foundation pit support system under stress. 2、Quick hardening cement seal-ing+polyurethane grouting sealing scheme. When using fast hardening ce-ment sealing and polyurethane grouting sealing, polyurethane is mainly in-jected into the anchor hole of the plain pile, and the grouting pressure is small, which has little impact on the stress stability of the foundation pit support system. Moreover, polyurethane foam material and fast hardening cement are only used for sealing at the end of the anchor hole, with small dosage and low cost. Therefore, the anchor hole plugging scheme for this project adopts fast hardening cement sealing+polyurethane grouting sealing, and the specific implementation is as follows:

① Quick hardening cement material sealing. Mix the quick setting plugging material and water in a ratio of 1:6.6-4 to form a wet salt like body. When the plugging material heats up and becomes slightly hard, insert it into the an-chor hole and compact it layer by layer with a hammer or wooden rod. The clumps of quick setting plugging material immediately expand and solidify slightly in the hole, and react with the anchor hole to form a solid whole. Af-ter the layered and staged sealing is completed, the clear water is discharged by the water guide pipe, the water pressure is reduced, and a layer of quick setting material (quick setting plugging material: water=1:0.5-0.6) is applied.

② Polyurethane foam material sealing. Inject the polyurethane foam material through a hydraulic injection needle until the polyurethane foam material flows out from the support surface, completing the injection work. After the anchor cable is tensioned and locked, polyurethane foam waterproofing ma-terial is used for the second
