Analysis and Treatment of Limit Invasion of Retaining Piles in Deep Foundation Pit of a Subway Station

Abstract. This study delves into the limit intrusion of retaining piles in deep foundation pits of subway stations, analyzing the bearing capacity after the removal of over-limit retaining piles. Drawing upon a specific engineering case, it proposes a systematic solution to address the intrusion of retaining piles beyond the structural boundary during excavation. The research reveals that factors such as stratigraphic characteristics, construction seasons, equipment precision, and personnel operations can contribute to the intrusion. Corresponding remediation measures are outlined for varying degrees of intrusion, along with the implementation of reasonable load-transferring components to ensure the safety of subsequent excavation. This study provides valuable insights for similar engineering projects.

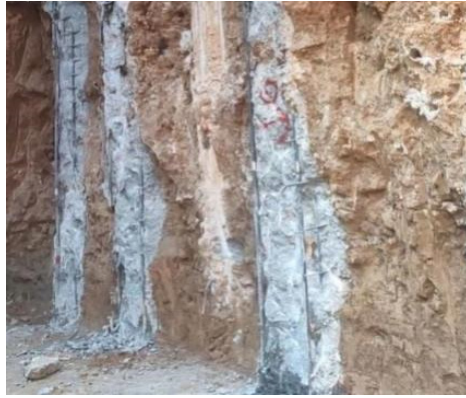
Fig. 4. On-site chiseling of pile foundation protective layer

Because the protective layer thickness of the enclosure pile is 70mm, and the enclosure pile with an invasion limit of 70 mm or less, the concrete with an invasion limit is chiseled without affecting the main reinforcement of the enclosure pile, and the concrete with an invasion limit is chiseled directly, as shown in Figure 4.

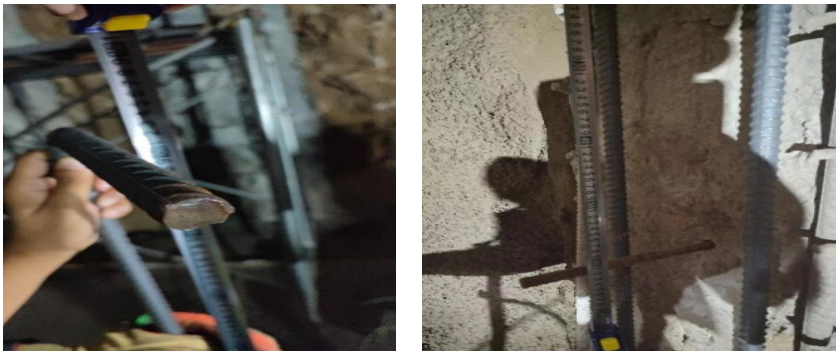
Fig. 5. Reinforcement nail lengthening encryption diagram

(1) manually remove the concrete to the uninhibited position, remove the concrete after the reinforcement of the main retaining pile, bend the original main reinforcement inward, and repair weld the upper and lower uninhibited positions with $\Phi 25$ reinforcement, and the double-sided welding length is $>> 125\text{mm}$.

(2) The reinforcement nails between piles will be lengthened from 1m to 1.5m, and the vertical spacing will be encrypted from 1.2m to 0.6m, so that the confined area can be closed quickly, as shown in Figure 5.
