Analyzing the Geotechnical Aspects of Landslide Events and Disaster Vulnerability along CPEC route in Gilgit Baltistan

M. A. Tanoli et al. (eds.), *Proceedings of the 1st International Conference on Climate Change and Emerging Trends in Civil Engineering (CCETC 2024)*, Advances in Engineering Research 248,

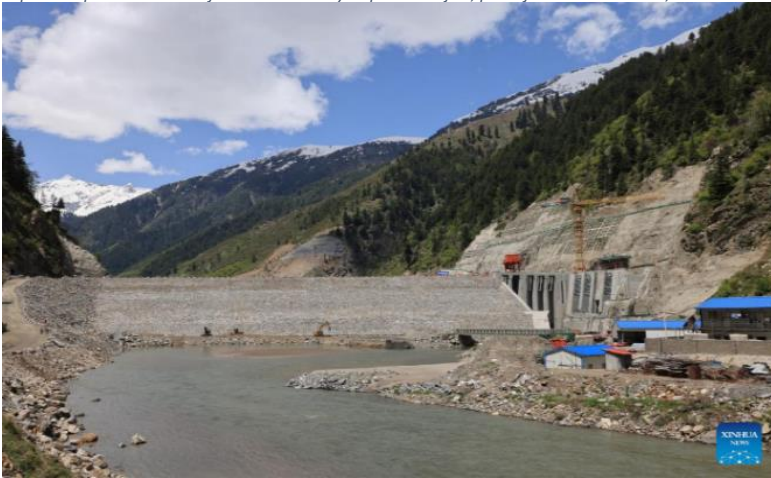
Figure I: The photo captures the dam of the Suki Kinari Hydropower Project, part of the CPEC initiative, located in the Mansehra

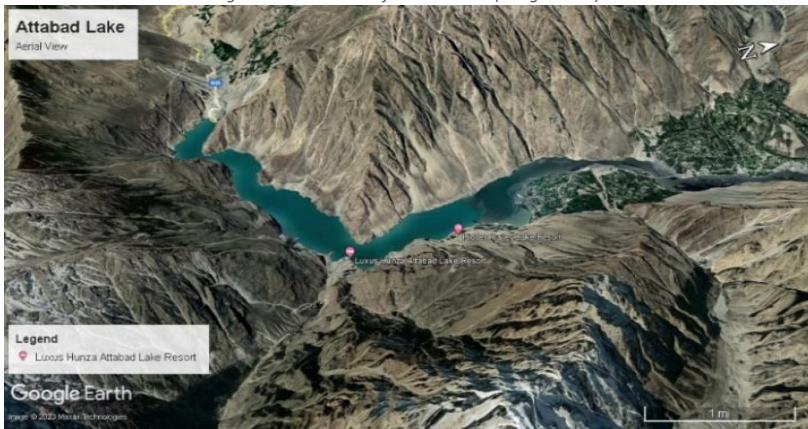
Figure IV: Aerial View of Attabad Lake (Google earth).

The Attabad landslide in Hunza, Gilgit Baltistan stands as one of the largest landslides in the history of Pakistan, occurring along the world's highest and strategically significant highway. On 4th of January 2010, a massive volume of rock slid down the slope of 45 million cubic meters, traversed a distance of 1062 meters and block the flowing Hunza River. As a result, an artificial dam formed due to the blockage. In as far as scientific terms are concerned, the Attabad rock avalanche was considered time-dependent and non-seismic, which killed 20 people and eliminated two villages, namely; Attabad and Sirat. The landslide continued 1062 meters from the origin to the limit of the deposition area, where 410 meters represented a source area. (Gardezi, Bilal, Cheng, & Xing, 2021).

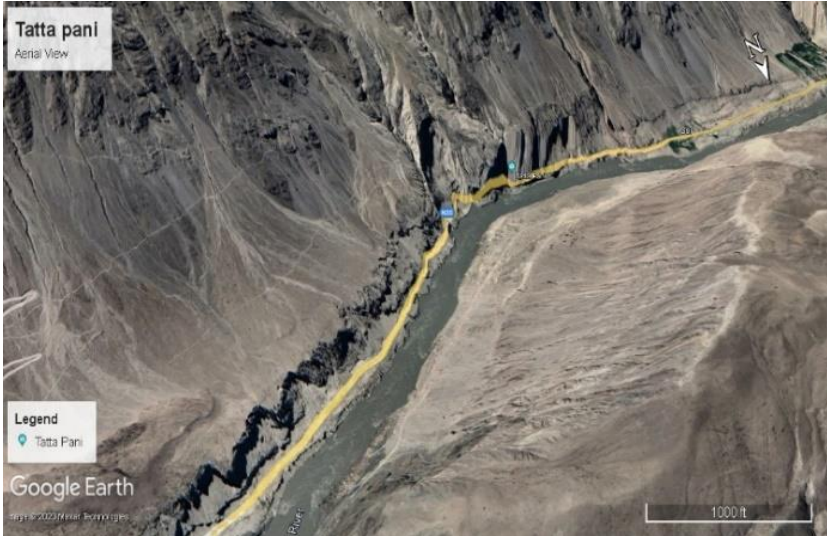
Figure VI (b): Aerial View of Tatta Pani area along KKH (Google earth).
