Analysis Of Transportation Facility At The Intersection Of Phh Mustofa Street And Ahmad Yani Street In Bandung City

Abstract. Bandung is a prominent city in Indonesia that encounters substantial challenges related to traffic and transportation, including congestion. Intersections are locations where cars from many directions converge and must halt or alter their course. An effective intersection can enhance traffic flow, mitigate congestion, and maximize the utilization of road space. Traffic infrastructure often present at signalized intersections comprises Yellow Box Junction (YBJ) traffic signs, Ruang Henti Khusus (RHK), pedestrian pathways (sidewalks), zebra crossings, bicycle lanes, traffic signals, traffic signage, road medians, and street illumination. This study focuses on the intersection at the traffic signal on JL. Phh. Mustofa and JL. Ahmad Yani in the city of Bandung. The infrastructure and traffic amenities at this crossroads require assessment to confirm compliance with safety and user comfort criteria. The data gathered for this research originates from field surveys, rendering it primary and current. The study results indicate that sidewalk conditions are poor, th

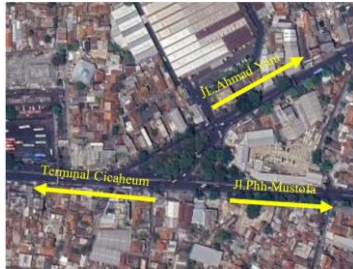
Fig 2 Intersection of Phh Mustofa-Ahmad Yani Road

The intersection is a single-plane configuration featuring a three-legged design, resembling a Y-shape with a turning road. The quantity of lanes for the roadway determined by the orientation of the road segment:

- The Phh Mustofa Street features a four-lane configuration with a central median.
- Cicaheum Terminal Direction: Four lanes with a median.
- Ahmad Yani Street: Four lanes with a central median.

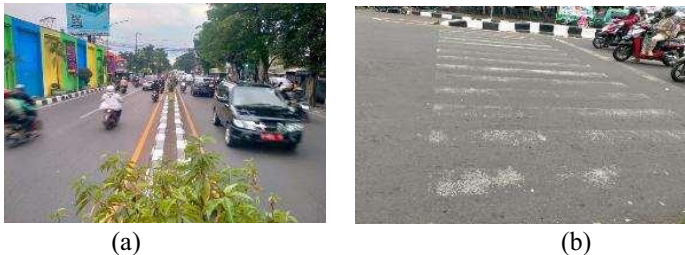
Fig 3 (a) Median on the road at Phh Mustofa Street. (b) Zebra crossing on Phh Mustofa street.

The identification of traffic issues is typically associated with congestion and the comfort of road users. The problems that emerge typically hinge on land use planning and the infrastructure's capacity to facilitate access. The intersection of Jl. Phh Mustofa and Jl. Ahmad Yani faces several challenges, including vehicles halting at arbitrary locations, which obstructs traffic flow; insufficient street lighting that endangers road users; obscured traffic signs; and the inappropriate use of sidewalks for parking. The following conditions apply to the establishments situated on Phh Mustofa Street:

1. The compatibility of transportation infrastructure
Repainting the dilapidated zebra crossings and Yellow Box Junction with weather-resistant paint would ensure road users' safety and visibility. The local authorities may also install zebra crossing and Yellow Box Junction signs or maintain them. Trimming vegetation or moving traffic signs can fix the issue. Finally, monitoring and control or warning or prohibition signage can reduce vehicles stopping improperly. Another approach is to build shelters or rest areas.

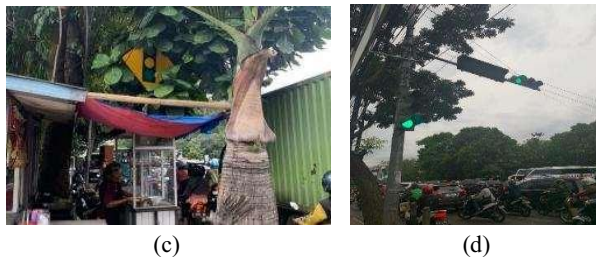
Fig 4 (c) Traffic Signs on Phh Mustofa Street. (d) Red Light at the Intersection of Phh Mustofa Street and Ahmad Yani Street

The condition of the traffic signs at the intersection is largely obscured by vegetation, making them less visible to road users. This poses a danger to road users both at night and during the day.

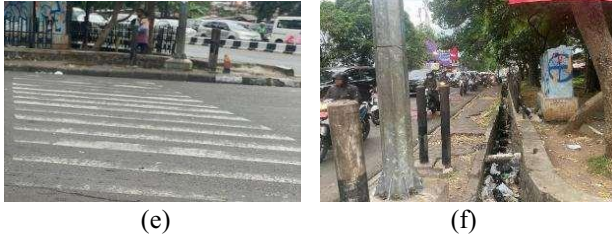
Fig 5 (e) Zebra crossing on Ahmad Yani street. (f) Sidewalk on Ahmad Yani Street

The condition of the infrastructure on the sidewalks is poor; the materials on the sidewalks are damaged, and the sidewalks have been repurposed as parking spaces. This causes pedestrians to choose to walk in areas designated for motor vehicles, which can lead to traffic accidents. In addition, the poorly maintained drainage conditions lead to blocked water flow and increase the potential for flooding.

2. Infrastructure Condition
The motorbike parking area and pathways need repairs or maintenance from the local authority. Additionally, local authorities should limit or prohibit parking on sidewalks turned into parking areas. Community clean-ups, drainage channel closures to deter littering, and local citizen stewardship to prevent road floods can fix refuse-obstructed drainage systems.

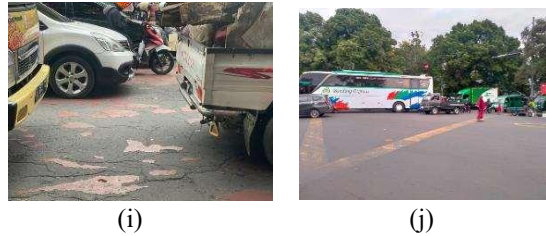
Fig 7 (g) Condition of Motorcycle Stop Space. (h) Condition of Yellow Box Junction.

The aforementioned scenario indicates the improper usage of a motor stop area, which is currently occupied by vehicles with four or more wheels, in conjunction with the deteriorating state of the road exhibiting cracks. Furthermore, figure 7 illustrates that the quality of the zebra crossing has deteriorated and become indistinct. The zebra crossing and the quality of the Yellow Box Junction both appear to have deteriorated and become ambiguous.
