# Analysis of the Role of Solenoid Valve on Foodstuff Cooling Machine on MV Ship. Double In

**Abstract.** This research was conducted during PRALA (Sea Practice) on the MV. Double In, managed by CHH Shipping Management Co. Ltd., over a period of 12 months and 2 days. Data was gathered through on-site observations, ship documents, and photographic records, and analyzed using SPSS. The results revealed a buildup of dirt on the solenoid valve due to a contaminated air dryer, leading to freon circulation issues. Consequently, cleaning and replacement of solenoid valve components and air dryers were carried out, followed by regular maintenance to ensure optimal function.

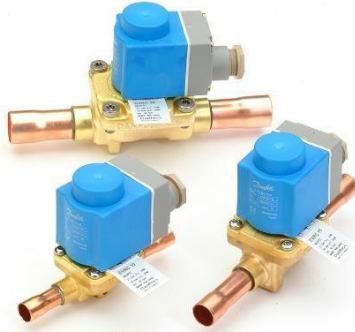
**Fig. 1.** Refrigerator Selenoid Valve (Danfoss BF230)

A solenoid valve is a valve controlled by electric current through a coil or solenoid, widely used in fluid systems such as pneumatic, hydraulic, and automatic machine control. In a cooling machine, the solenoid valve functions to regulate the flow of liquid refrigerant to the evaporator according to the temperature needs of the food storage room, which is controlled by a thermostat. Solenoid valves work by applying electricity to the coil, creating a magnetic field that lifts the valve needle, allowing liquid refrigerant to flow to the expansion valve and evaporator. The thermostat controls the flow of electricity to the solenoid valve coil, connecting it or disconnecting it based on the temperature of the room to maintain the desired temperature [7].

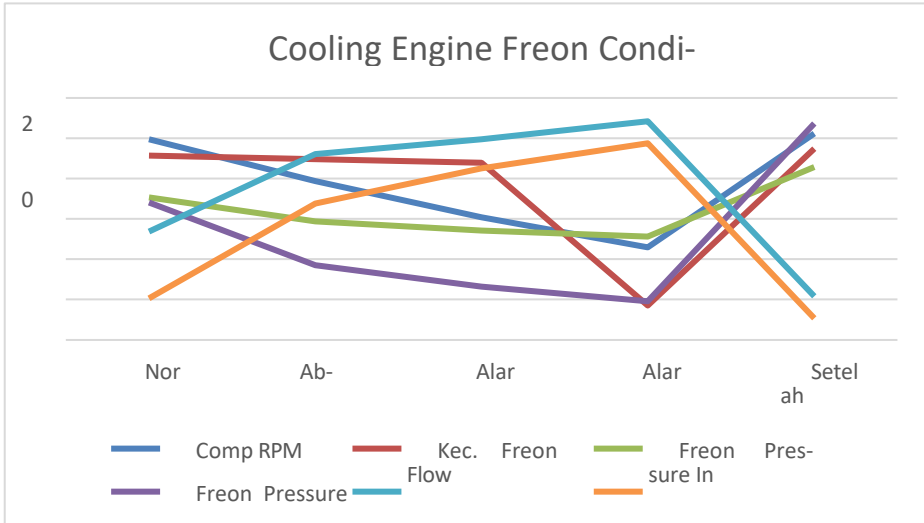
Fig. 3. Compressor performance on August 24-25, 2023

The analysis results indicate that the graphs reflect how the operating conditions of the refrigeration machine and freon-related parameters vary under normal, abnormal, alarmed, and repaired conditions. These fluctuations are useful for analyzing the issues and evaluating the effectiveness of repairs. The data can also be further analyzed to assess the performance of the refrigeration system and identify maintenance needs based on patterns observed in the operational data.

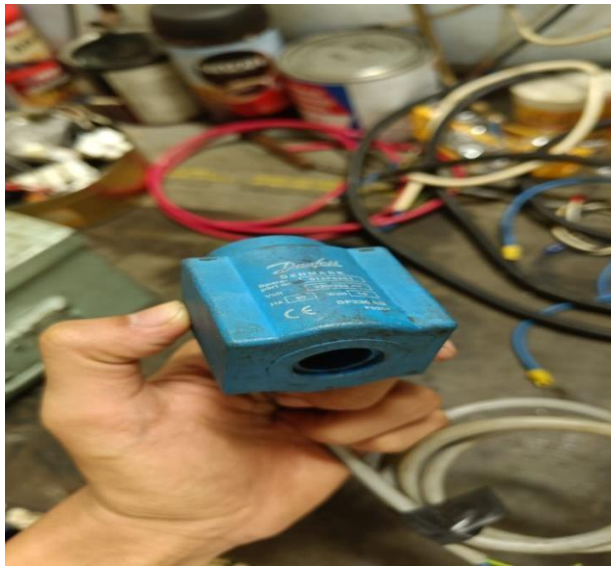
During the disassembly of the solenoid valve, it was found that dirt had accumulated, obstructing the freon circulation in the system. This issue occurred because the air dryer filter was dirty, causing the air dryer to malfunction. As a solution, the air dryer and solenoid valve were replaced. Proper maintenance and optimal operating conditions are crucial to prevent similar breakdowns in the future.

**Fig. 5.** Damaged Solenoid Valve

4. Repair on damaged components
  - a. Refrigeration engine solenoid valve replacement
    - (1) Preparation of a new solenoid valve
    - (2) Installation of a new solenoid valve
  - b. Replacement of air dryer components
    - (1) Preparation of the new air dryer
    - (2) Installation of a new air dryer
  - c. Line cleaning of the cooling system  
The method used to clean the cooling system from water or dirt is to use nitrogen to blow through.
  - d. Cooling system vacuuming
    - (1) Connect the vacuum pump hose, turn on the pump and wait 20- 30 minutes.
