Engineering geological consideration of a deep pump house foundation floor: case study of lift irrigation scheme, India

National Institute of Rock Mechanics

Abstract—Geological mapping of deep foundation floor is essential to provide permanent data set for geological interpretation. A deep pump house (94 m long x 20 m width x 78 m deep) of Mahatma Gandhi Kalwakurthi Lift Irrigation Scheme-II (MGKLIS-II) was constructed at Mahaboobnagar District in Telangana State for the irrigation of drought prone upland areas. Engineering geological mapping on 1:200 scale of foundation floor of pump house was carried out in order to evaluate the basic design parameters. All the discontinuities in the rock mass of pump house area with the zone of influence of the foundation were identified and mapped. Mapping was done to assess the requirement of any ground improvement by adopting suitable engineering measures. Safe bearing pressure of the foundation was estimated by rock mass rating, rock mass characteristic parameters. Based on investigations geotechnical problems were identified and suitable engineering measures for rock support were suggested to make foundation monolithic.

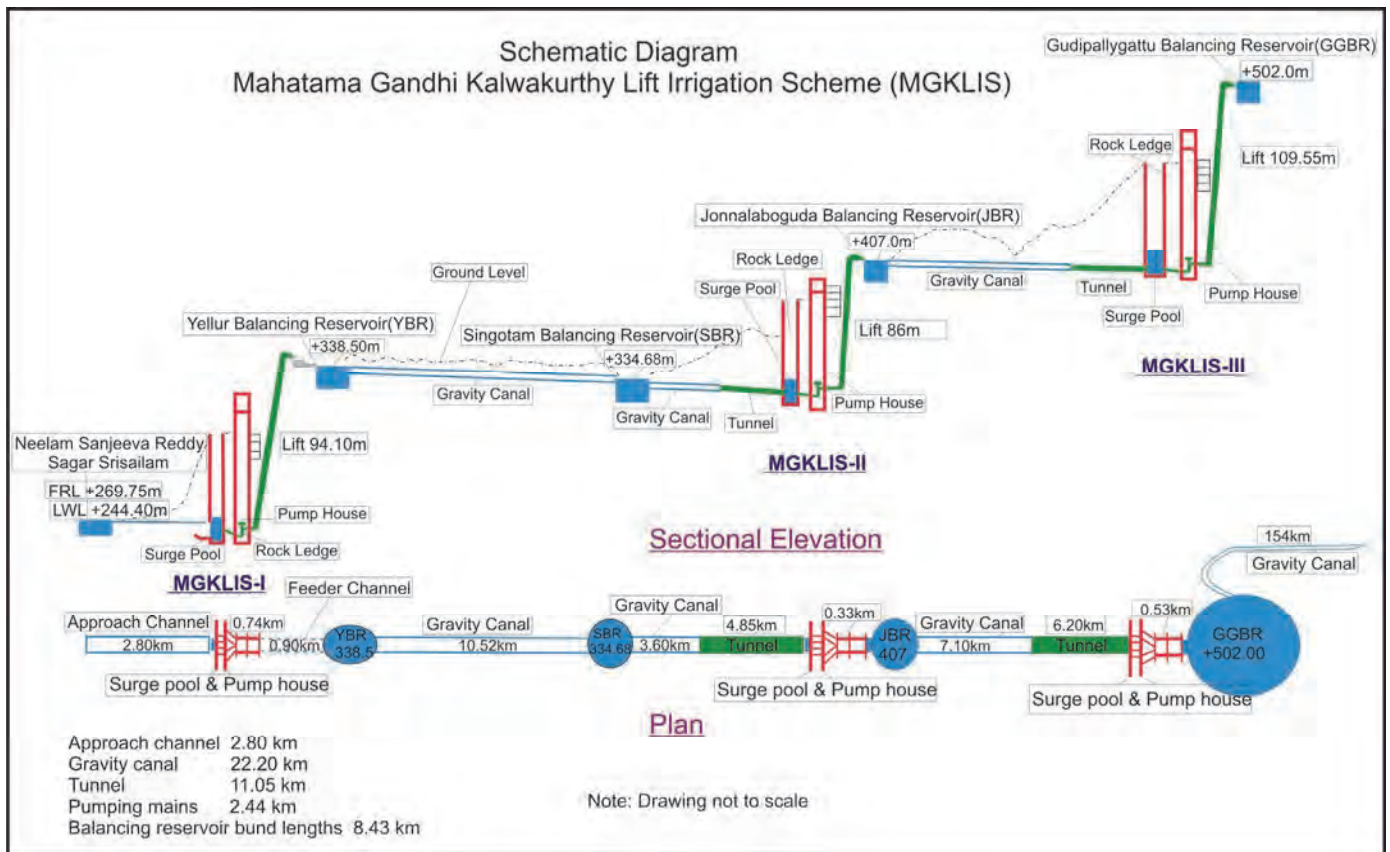
Fig.1. Plan and elevation of schematic drawing of MGKLIS [1]

Mahatma Gandhi Kalwakurthy Lift Irrigation Scheme (MGKLIS) is proposed to provide irrigation water to an extent of 3.40 lakhs acres and utilising 25 TMC of water including drinking water facilities to 3,20,000 population (0.73 TMC) to chronically drought prone upland areas in Mahaboobnagar district covering about 303 villages in erstwhile taluks of Kollapur, Nagarkurnool, Achampet, Jadcherla and Kalwakurthy constituencies in 19 Mandals. This scheme (MGKLIS) was constructed having the three stages (I, II & III) for lifting the Krishna water from Srisaillam reservoir (back water) to Gudipallygattu balancing reservoir through channels and tunnels (Fig. 1). Water will be lifted to a total height of 289 m in three stages from level +244.40 to +502.00m.

The major components of the project are: one 4 km long gravity canal from Singotam balancing reservoir having bed width of 19.15 m, one 4.53 km long and 6.85 m finished diameter 'D' shaped tunnel, one surge pool (94 m long x 40 m width x 75 m height), five 50 m long draft tube tunnels, one pump house (94 m long x 20 m width x 78 m height) and five (3 m finished diameter), 15 m length horizontal and 305 m length inclined (45°) main delivery tunnels. Lift height is 86 m and five pumps installed in the pump house cavity (30 MW capacity each). Design discharge of the pumps is 113.2 Cumec. This study pertains to large scale engineering geological mapping on 1:200 scale of excavated floor foundation of the pump house. The objective of this study was to advise suitable protective engineering measures of excavated foundation floor of pump house based on detailed engineering geological investigations.

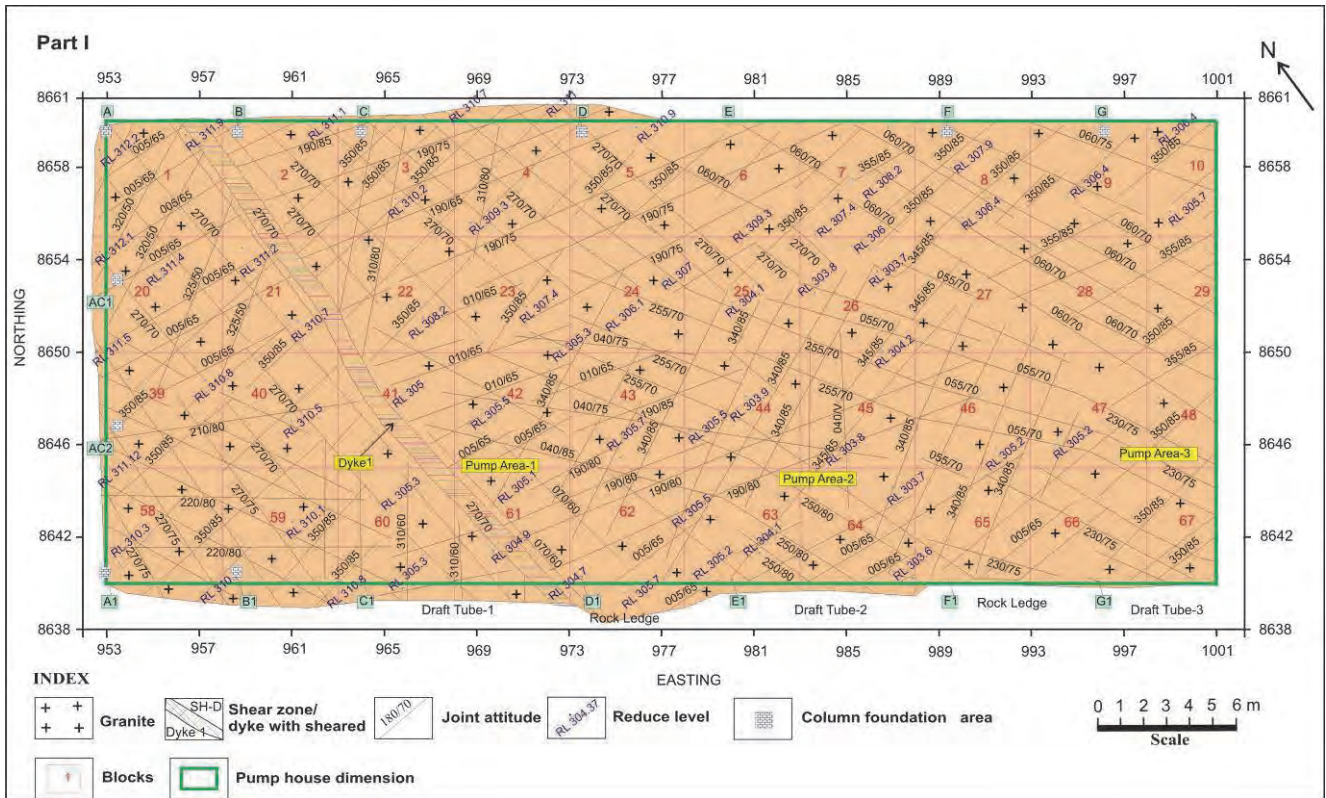
Fig. 2 (part I). Geology map of foundation of pump house of MGKLIS-II

The design foundation level is at RL +305.40 but in some areas it is excavated up to an average RL +303 and the over excavation was varying from 0.10 m to 2.4 m because of presence of unfavourable discontinuities, and shear zones. The foundation of pump house will be resting as per design on a raft of 300 mm thick at about 78 m below the existing ground level for functional requirement (Fig. 3). Total 1880 sq m excavated foundation area of pump house floor has been geologically mapped. Geological foundation mapping was done after the excavation and before first pour of concrete (Fig. 4). Based on the field observations and evidences, it is found that the entire floor area consists of coarse grained, hard and jointed pink granite (Fig. 5). Total four shear zones are mapped. The width of the shear zones are varying from 1 cm to 30 cm. No displacement has been recorded along shear zones. No evidences of faulting are observed on the surface of floor area. The structural features observed during the mapping indicated the need for consolidation grouting, so that the entire floor is function as single rock mass. On the basis of surface geological mapping the excavated surface is acceptable for foundation.

composition is alkali feldspars, quartz, mica and amphiboles. Five prominent joints set are developed and along the joint plane clay filling/coating was also recorded. Joints are irregular in pattern. Granites are generally fresh to moderately weathered (WI–WIII). At the foundation level granites are traversed by dolerite dyke (feature D1 marked in geological plan map). Dolerite dykes are fine grained and greenish-black in colour. The width of the dyke is up to 100 cm and strike length is more than 50 m in excavated part of pump house. Dyke is generally sheared and clay gouge was observed. Plagioclase and clinopyroxene (augite / titanaugite) are the main minerals occurring in ophitic to sub-ophitic textures in dolerite dyke. Quartz, epidote and opaques occur as accessories. Amphibole, biotite, sericite occur as alteration products. Dyke is generally highly weathered (WIV) as per the weathering grade. The rock mass is characterized by prominent five number of joint sets, which are continuous and persistent, slightly rough to smooth with unaltered joint walls. Staining has been recorded along the joint surfaces where the joints are tight and where opening is up to 50 mm, soft clay mineral and crushed material filling has been recorded. In general, the rock mass was characterized by dry condition or minor inflow i.e. < 5.0 l/min. Crack/fractures developed due to excavation / blasting were also recorded during geological mapping. Some of the cracks are tight while some are open with size of the opening varying from 1 mm to 5 mm. Hairline cracks developed due to excavation work were also recorded. The prominent joints recorded in the coarse grained granite at the foundation of pump house are given in Table I.

The rocks exposed at the foundation grade of the pump house are jointed pink granite interspersed with sheared dolerite dyke. Shear zones having the varying thickness are mapped which are having differential mechanical behavior due to varying physical properties leading to differential settlement. In order to overcome the problem of differential settlement shear zones treatment plan as given in Table V was suggested.

Based on the structural features mapped, consolidation grouting up to 6.0 m depth using primary, secondary and tertiary holes was recommended so that the entire floor area functions as a single rock mass. The pressure and proportion of grout mixes to be used for injection shall be based on water pressure test and the results of trial grouting

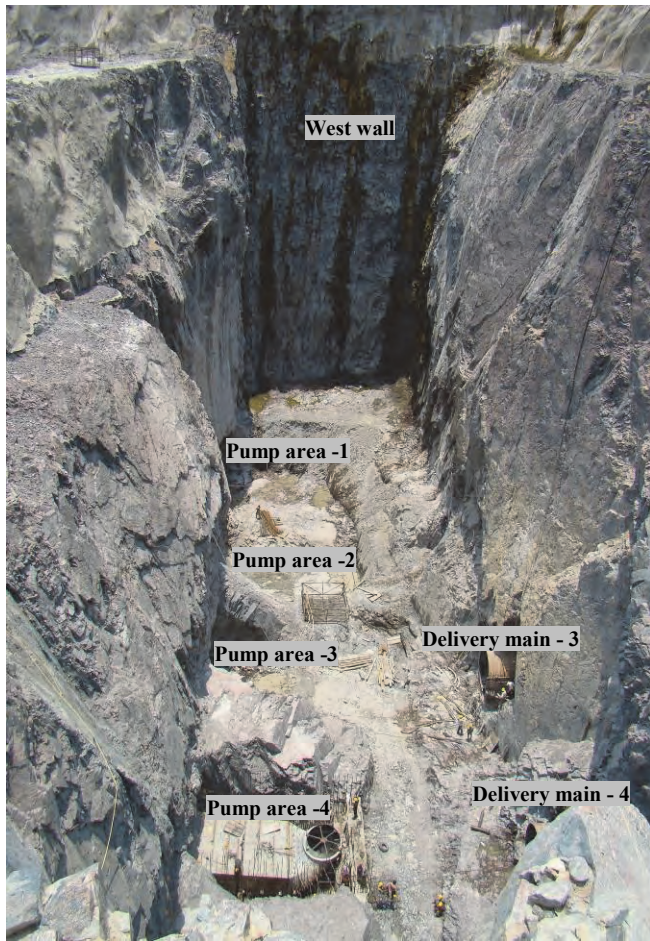
Fig. 3. Pump house area, viewing towards left side i.e. western direction

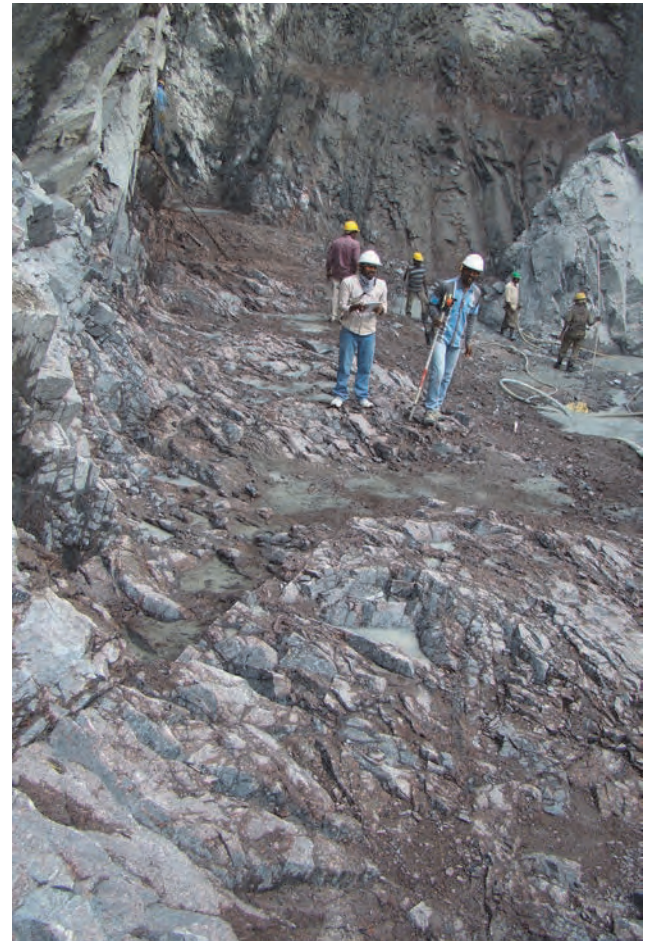
Pink granites are coarse grained, hard and jointed and shows phenocryst of alkali feldspar and quartz. Main minerals

Fig. 4. Pink granite mapped at the foundation of pump house

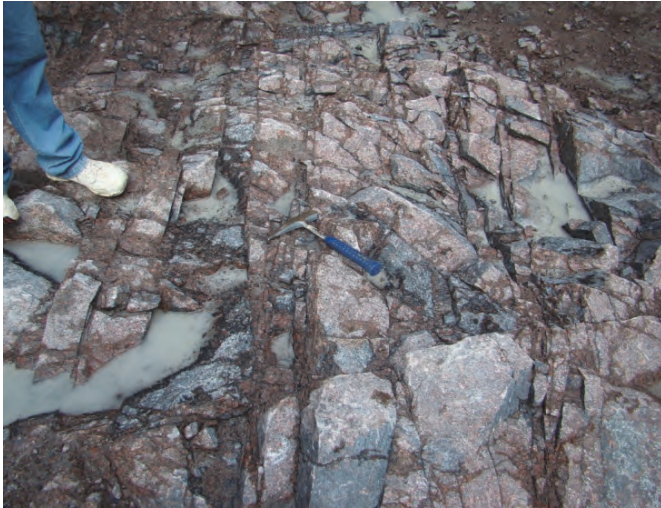
Fig. 5. Prominent joints at the foundation of Pump house
