Impact of Coastal Erosion and Tidal Flood to Land Loss at Sriwulan Village, Sayung, Demak, Central Java Province

Abstract—This study was aimed to (1) determine the hazard level of coastal erosion and tidal flood, (2) total land loss due to coastal erosion and tidal flood, (3) the people perception against coastal erosion and tidal flood disaster in Sriwulan village, Sayung Sub-district, Demak, Central Java Province. The study was conducted by analyzing and overlapping maps, observing the field and interviewing the residents. The results showed that (1) most of the Sriwulan village was inundated by tidal flood every day from a few centimeters to more than 1 meter, (2) during the period of 2003 to 2016 there had been 60 hectares land loss, consisted of 51 hectares of fishpond and 9 hectares of settlement, (3) residents were disturbed by the coastal erosion and tidal flood; however, the government had not taken any concrete moves toward these problems yet.

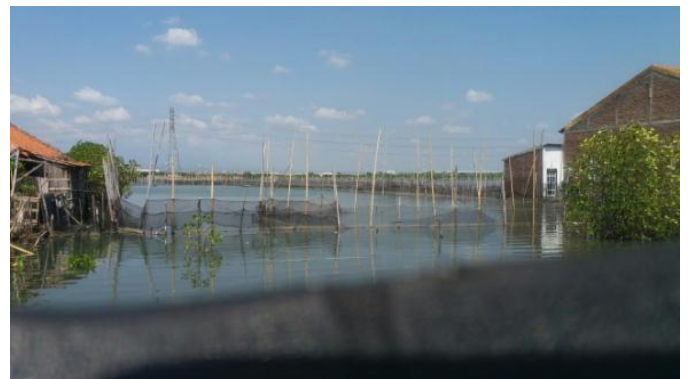
Fig. 2. Fishpond condition in research area

In the research area the paddy fields have turned into fishponds, while the former fishponds that have been permanently inundated turned into part of the sea. Fishponds that are still functioning are in alarm condition because the higher the inundation the higher cost to install nets around it.

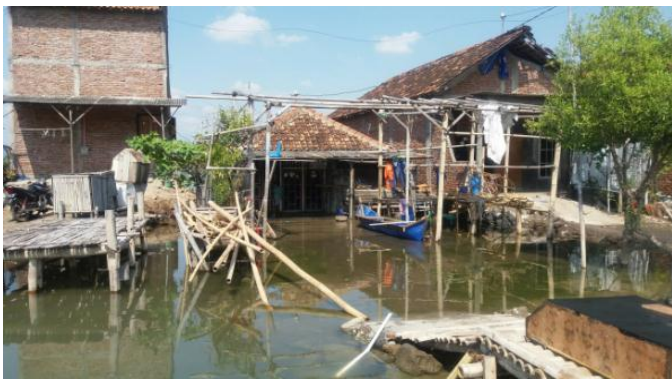
Fig. 3. Tidal flooding adaptation with higher the house and providing boats

Residents have issued a large cost to lift the house floor so that water did not enter the house, but it only lasted for a few months since the water keep flooded their homes because of the increasing intensity of the tidal flood. Residents who cannot tolerate these conditions choose to move to another place and leave their homes.

The families who stay in the study area have no other choice but adapting to the waterlogged conditions every day. Some families whose homes were flooded quite high, providing boats for mobilization.

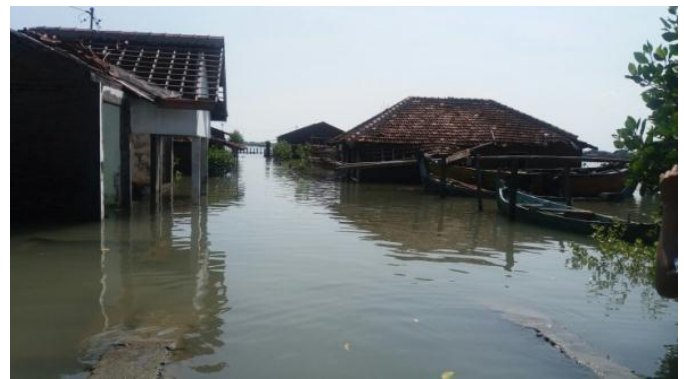
Fig. 4. The houses were abandoned, but still visible as a settlement in the image analysis

The houses which were permanently flooded and no longer habitable were still visible on the image and interpreted as a settlement, so that in reality the reduction of residential land is more than the results of image interpretation.
