Analysis of the Structural Characteristics of Rural Residential Buildings in Hainan Province

Keywords: Hainan; township rural houses; seismic performance; sampled detailed inspection of building construction

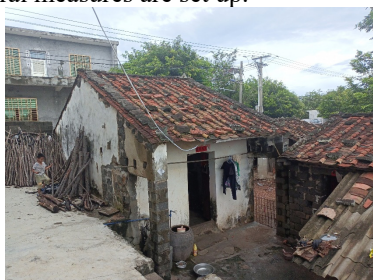
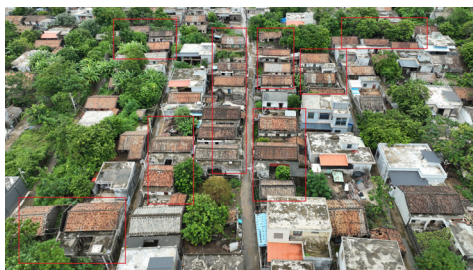
This kind of structure is mostly stone-wood structure, and the number of layers is generally single layer (Figure 4a)). It accounts for about 9 % of the township survey area of Hainan Province, and there are still residents living or using it. This kind of structure uses volcanic stone as masonry material after processing, and the roof truss is a wooden roof truss, which is called the 'tile-roofed house ' by residents, and no structural measures are set up.

Fig. 4. Stone-wood structure rural house and its aerial photography

Lingao County, and Sanling Village in Tunchang County accounted for more than 40 %. Figure 4 b) shows an aerial photo of the village in the field survey. The buildings in the red box are all stone and wood structures built before 1990.

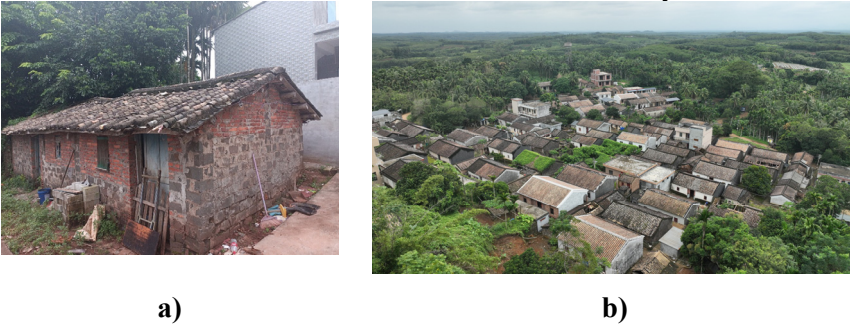
Due to the development of the economic level, the buildings in this period gradually began to use sintered clay bricks to build walls. However, the amount of brick is not much, and many houses are brick-stone mixed structures(Figure 5). The common structural forms include brick-stone mixed structure and brick-wood structure, both of which are single-layer. The total proportion in the survey area is about 33 %. The brick-stone mixed structure adopts volcanic stone as the masonry material of the lower wall, the upper part of the wall is made of sintered red brick, and the roof truss is a wooden roof truss. Brick and wood structures all use sintered bricks as masonry materials.

Fig. 5. Brick-stone mixed structure and the aerial photography of brick-wood structures in Shimengao Village

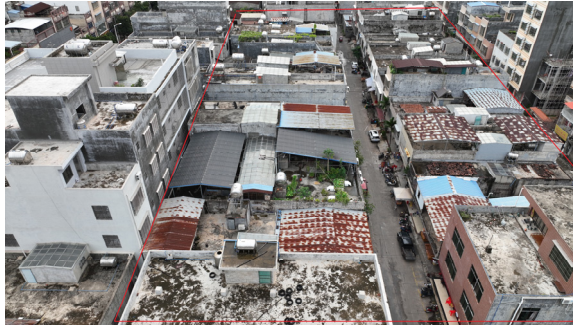
In each survey point, compared with the village, the economic development of the town is better, and the brick-concrete structure in the town accounts for a larger proportion. In the red box of Figure 6, the brick-concrete structure houses near Hongwei Street, Lincheng Town, Lingao County, were built between 2000 and 2010. The number of brick-concrete structures in this area accounted for 60.09 %.

Fig. 6. Aerial photo of brick-concrete structures in Lincheng town, Lingao County

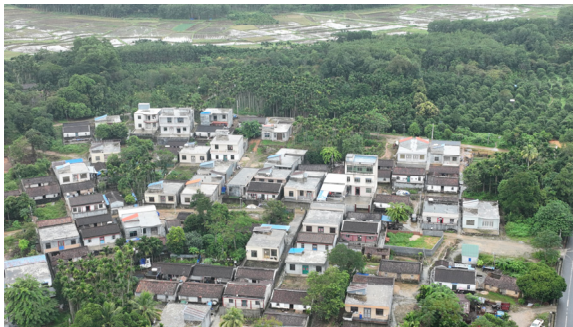
Fig. 7. Aerial photo of frame structures of Sanling village, Tunchang County

The white flat-roof houses in Figure 7 are frame structures, which are newly built buildings in Sanling Village, Tunchang County, accounting for 43.84 % of the total number of buildings in the village.

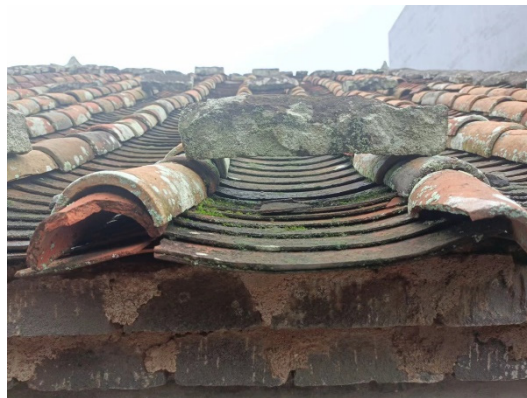
The masonry materials of stone-wood structures are mostly volcanic rocks excavated by residents in situ. The modulus is different from that of ordinary sintered bricks used in recent years. Therefore, the wall thickness of stone-wood structures is different from that of brick masonry structures, such as 240 mm and 180 mm. The wall thickness of the stone-wood structure is mostly 300 mm. The roof is a double-slope roof, and the roof structure is a purlin-on-wall flush-gabled roof. The roof material uses small green tiles, which are called 'tile houses' by residents (Figure 9).

Fig. 9. Detailed drawing of the Chinese style tile on the top of the stone-wood structure in Hainan Province

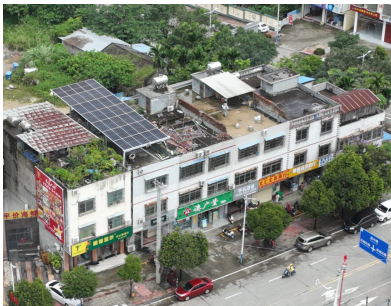
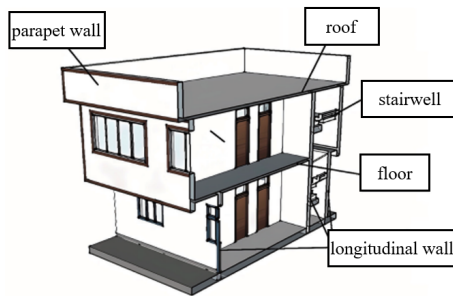
Fig. 16. Brick-concrete structure and its structural schematic diagram in Hainan Province

Most of the rural houses built in Hainan Province from 2000 to 2010 are brick-concrete structures (Figure 16). The wall is made of sintered clay bricks, and the beams, slabs and columns are made of reinforced concrete materials. Such buildings have a huge stock in Hainan Province and are distributed in urban and rural areas. The number of floors of the building is mostly 2 ~ 3 layers, the building plane is mostly rectangular, and there are also irregular layouts. The building facades are also mostly rectangular, and some buildings have two floors over a layer of cantilever. The depth is mostly 6m, and the opening is 10m.

Most of the brick-concrete structures in Hainan Province adopt the mixed load-bearing of vertical and horizontal walls. The vertical and horizontal walls are generally connected with steel bars, and the integrity is good. The mortar is cement mortar, which has high strength. Most of these buildings consider the ring beam and constructional column in the design, and the floor is mostly cast-in-place, which has a certain seismic capacity. The foundation adopts the strip foundation.

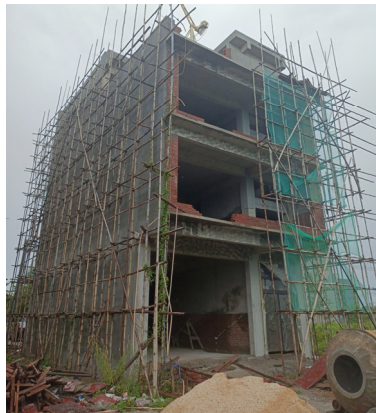
Fig. 19. A framework structure under construction in Hainan Province

With the development of the economic level, frame structure houses gradually appeared in township areas of Hainan Province after 2010. The frame structure houses use reinforced concrete materials as beams, columns and plates, and the filled walls are made of ordinary sintered bricks. Such buildings are mainly distributed in urban areas of Hainan Province (Figure 19). In recent years, there have been many new repairs in rural areas. The area of frame structure type houses in Hainan Province accounts for about 70.6 %, and the number is relatively large. The frame structures in the township areas of Hainan Province are mostly 2-3-storey self-built houses, and there are also single-storey buildings. In addition, the frame structure buildings in most townships and towns retain and rust-proof the exposed column steel bars on the top floor, so that the residents can cover the floors when they are richer in the future.
