Experimental Study on Damage and Protection of Steel Structure Plant under Explosion Impact

Abstract. In this paper, the dynamic response and damage consequence of the steel structure under the blast impact load are investigated by carrying out the full-scale model of the steel structure industrial plant and the near-earth explosion damage test of the local component. The near-ground explosion test was carried out, and the dynamic response and damage consequences of steel structure industrial plant were obtained. The anti-explosion effects of different protective measures were proposed and compared for the weak parts of the structure. The results show that the wall panel of the steel structure industrial plant will produce strong vibration and tear failure under strong impact load. Polyisocyanate oxazolonone (POZD) can effectively improve the anti-knock performance of wallboard, and the protection effect of double-side spraying is better than that of back-side spraying, and the effect of front spraying is the worst. The research results provide important engineering value for damage analysis and protection measures of steel structure industrial plant.

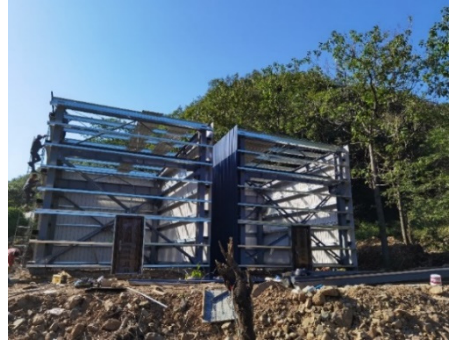
Fig. 1. Building model

According to the existing typical steel structure building, the single-storey single-span light steel structure industrial plant is designed. The main purpose of the test is to study the structural strength of the component, so other functions have been deleted. The plant is a single-storey building with a total height of 7.75 m, a length of 9m and a width of 6 m. The building structure is light portal steel frame structure, seismic fortification intensity is 7 degrees, the plant is equipped with crane beam, the project is destructive test temporary facilities, do not consider fire design. The exterior wall is made of 900 color steel plate with a thickness of 0.476 mm. The roof adopts single-slope single-ridge unorganized drainage, and adopts 0.6 mm thick 820 color steel plate. The model selected one side of the factory building to simulate the damage consequences of the existing typical steel structure industrial plant under strong impact load. The building model of the test plant is shown in figure 1.

(a)Schematic drawing

(b)Field drawing

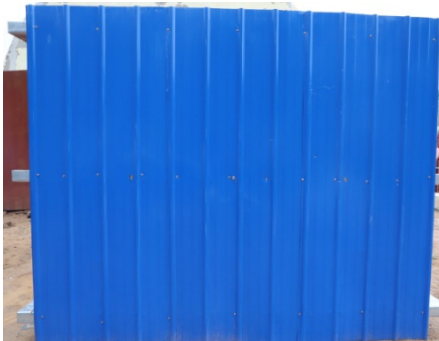
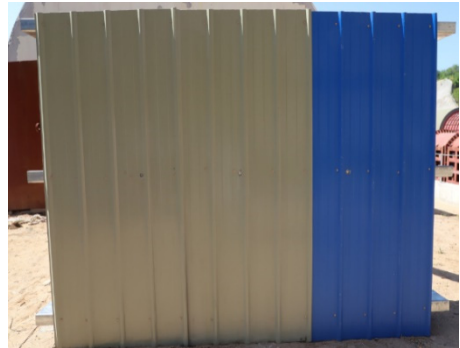
Fig. 2. Reinforced member

At the same time, considering that polyurea elastomer has good anti-explosion effect, and spraying on steel plate can effectively prevent steel plate corrosion and have a certain aesthetic effect, polyurea reinforced color steel plate and ordinary color steel plate anti-explosion test are used in local component tests, and their different damage consequences are compared, so as to explore the protective effect of polyurea on color steel plate. The field real explosion test was carried out under three conditions: ordinary unreinforced color steel plate, polyurea spray blasting surface, polyurea spray back blasting surface, and polyurea double-sided spraying, as shown in figure 2 below. Some parameters of polyurea are shown in table 1.

(a)Unreinforced color steel plate

(b)Reinforced colored steel plate

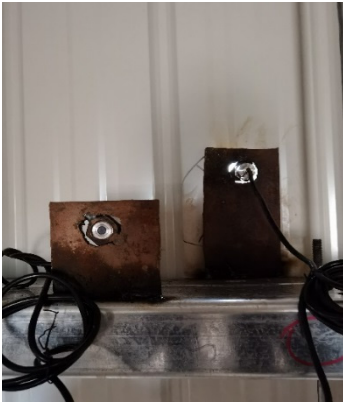
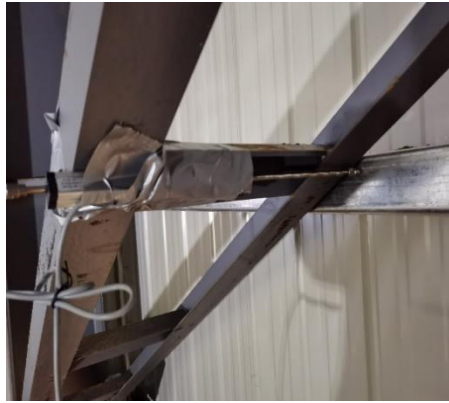
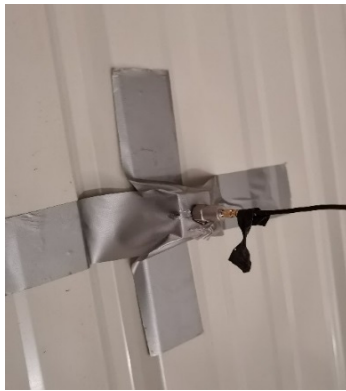
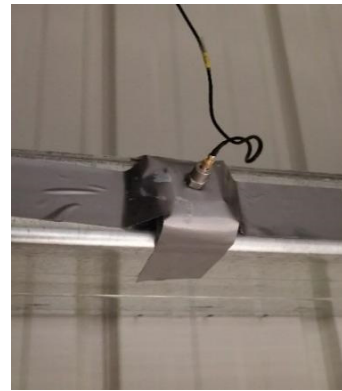
Fig. 3. Sensor layout

According to the actual building height, the position of displacement sensor, acceleration sensor and air pressure sensor is determined, considering the difference of strong impact load between the bottom and the top of the plant. The field layout of the air pressure sensor, acceleration sensor and displacement sensor on the explosion facing surface is shown in figure 3.

(a) Air pressure sensor

(b) Displacement sensor

(c) Plate acceleration sensor

(d) Skeleton acceleration sensor

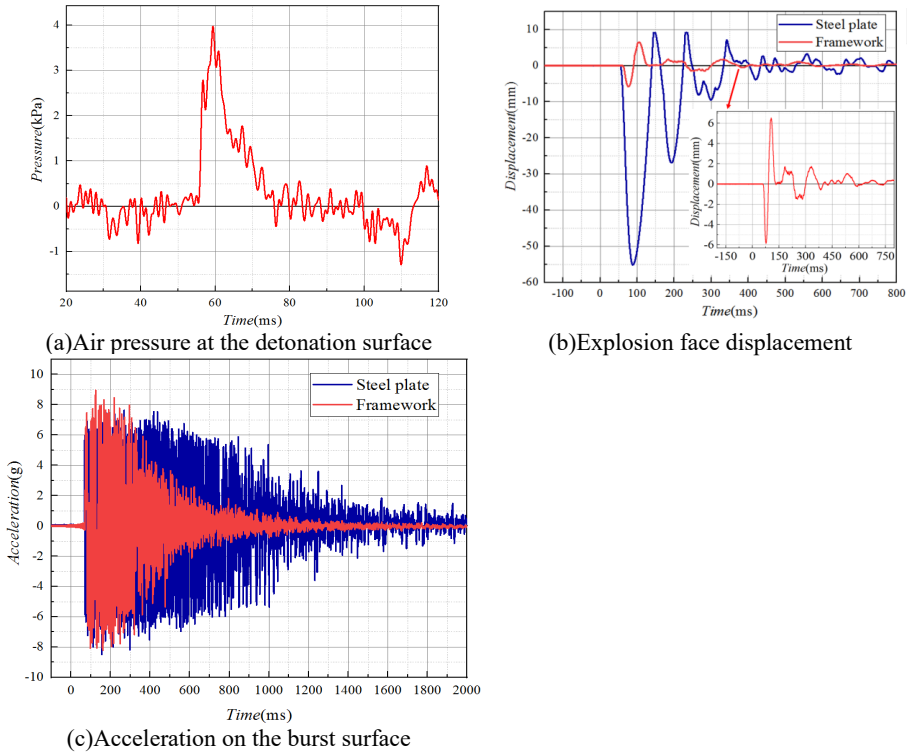
The first shot was tested with a proportional distance of 21.54 m/kg^{1/3}. The peak value of shock wave overpressure measured on the explosion facing surface of the plant model was 3.91 kPa, the displacement of the explosion facing wall panel was 55.124 mm, and the maximum displacement of the explosion facing purlin could reach 6.416 mm. Strong vibration will occur. Compared with the skeleton, the vibration amplitude is larger, the frequency is fast, and the duration is long. The test waveform of each data is shown in figure 5.

Fig. 5. First shot test waveform

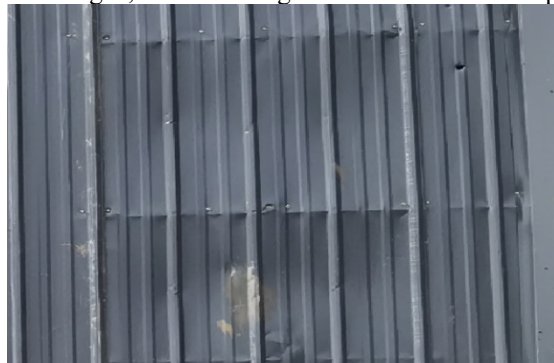
No obvious damage was seen in the overall structure of the first shot test plant, the explosion facing panel was slightly dented (figure 6), some wall color steel plates on the back explosion surface were loosened, the main load-bearing components of the test plant, such as steel columns and steel beams, were not damaged, the concrete foundation pile was not damaged, and no damage was found in the wall purlin.

Fig. 6. The blasting surface is deformed

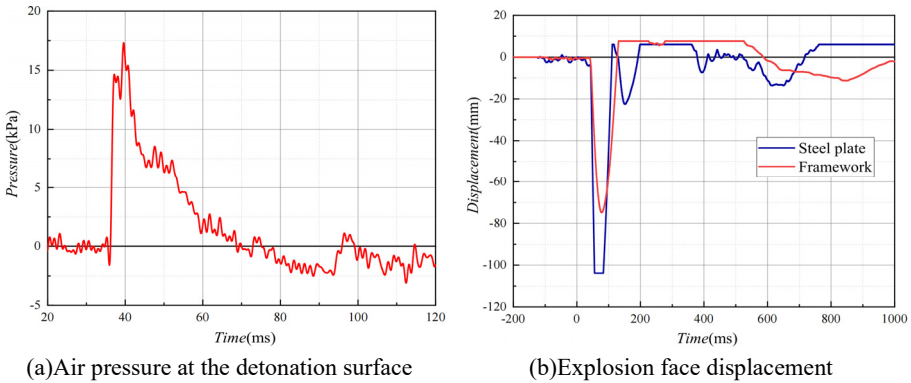
The second round was conducted on the basis of the first test at a proportional distance of $12.59 \text{ m/kg}^{1/3}$. Strong blast impact load has a great impact on the upper part of the plant. The effect value of strong impact load on the 5 m space of the model is significantly greater than that at the bottom of the model. The air pressure on the explosion facing surface of the plant is up to 17.57 kPa, while the air pressure on the back explosion surface of the plant is about 7.53 kPa. Lead to part of the displacement sensor to exceed the range and damage, after the test repair, screening, to obtain the estimated structural displacement, the maximum displacement of the wall to meet the explosion surface color steel plate is greater than 103.97 mm, the maximum displacement of the bursting surface purlin can reach 74.762 mm. According to the test data, the movement of the structural wall panel and purlin is irregular compared with the 100 kg TNT real explosion test after the explosion, the vibration gradually shows symmetry after the vibration release, and the wall panel and purlin are deformed, and the displacement can not be recovered. Due to the imperfect debugging of the test system in the early stage, all the acceleration sensors fell off and were damaged, and the data was confused and could not be quantitatively analyzed. The waveforms of air pressure and displacement are shown in figure 7.

Fig. 7. Second shot test waveform

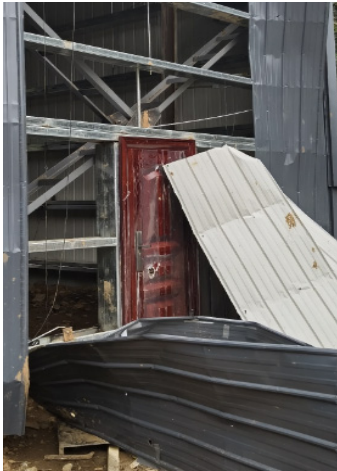
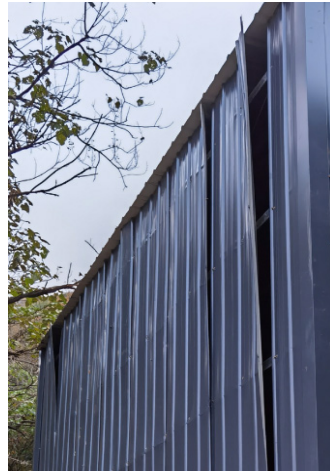
Fig. 8. The model is damaged

After the second shot test, the explosion facing surface of the test building was seriously damaged (figure 8), most of the color steel plate was damaged, and the color steel plate was torn or self-tapping fell off at the connection between the explosion facing color steel plate and the self-tapping, resulting in the wall color steel plate falling off, most of the sensors were seriously damaged, and each span of the bursting facing purlin was damaged to different degrees. The purlins bend and deform in the middle of each span, and the damage degree of the structural purlins at about 5.5 m in the upper part is significantly greater than that of the lower 2.2 m structure. The damage of the back explosion surface wall color steel plate is mainly concentrated in the structure of 6 m, and some of the connection parts of the color steel plate tear and fall off, which causes the joint effect, resulting in the overall color steel plate fracture and fall off, and the back explosion surface purlin structure has not found obvious damage. No obvious damage was found on both sides of the test building. No obvious damage was found to

(a)The blast face is damaged

(b)Back blow to the face

the reinforced concrete foundation and the anchor rod at the connecting position between the plant and the foundation. After careful observation of the high-speed camera, it was found that the wall panel of the test building was more strongly shaken when subjected to the strong impact load generated by 500 kg TNT explosive.

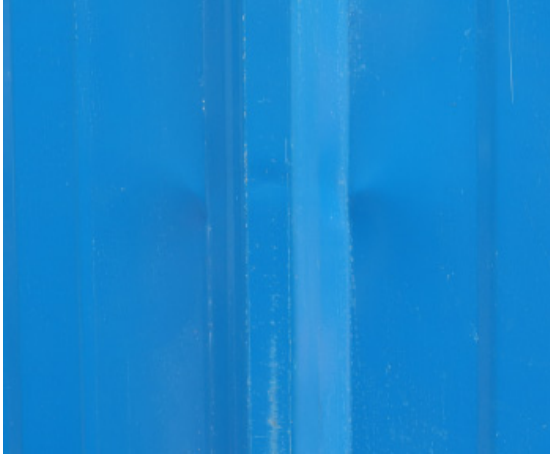
When the proportional distance is $10.77\text{m}/\text{kg}^{1/3}$, the color steel plate in the span and the purlin contact part due to purlin constraints and slight deformation, not with the purlin contact part is not found obvious deformation, as shown in figure 9. When the charge is 200 g and the explosion distance is 5 m, the longitudinal span of the steel plate is partially deformed, and the self-tapping joint of the steel plate and purlin is dented, as shown in figure 10. When the charge is 300 g and the explosion distance is 5 m, the longitudinal span of the steel plate has a large depression, and the purlin contact part has obvious deformation, some steel plate and purlin self-tapping joint tear, the damage mode is consistent with the prototype test, and the local steel plate is broken by the broken stone phenomenon, as shown in figure 11.

Fig. 9. Damage consequence of 100 g explosive plate

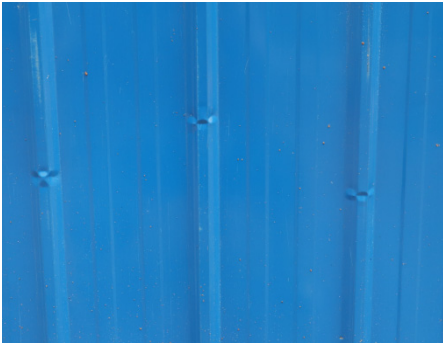
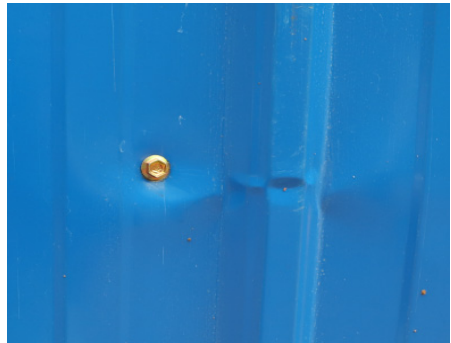
Fig. 10. Damage consequence of 200 g explosive plate

(a) The steel plate is damaged in the longitudinal span

(b) Purlin contact damaged

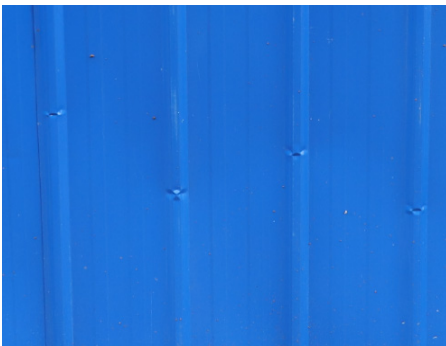
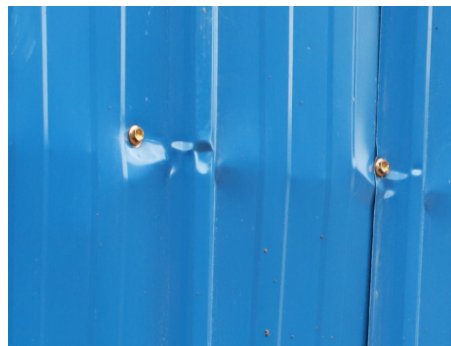
Fig. 11. Damage consequence of 300 g explosive plate

(a) The steel plate is damaged in the longitudinal span

(b) Purlin contact damaged

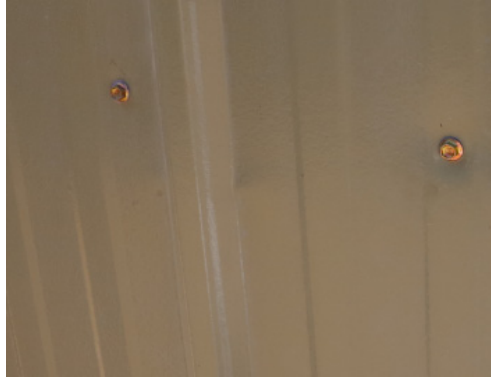
When the charge is 100 g and the explosion distance is 5 m, the color steel plate in the span and purlin contact part due to purlin constraints and slight deformation, compared with the unreinforced color steel plate deformation degree is low, not with the purlin contact part no obvious deformation, as shown in figure 12. When the charge is 200 g and the explosion distance is 5 m, the local deformation of the longitudinal span of the steel plate is less and the deformation degree is small, the deformation of the self-tapping joint of the steel plate and purlin is not obvious, and the breaking phenomenon is not found at the self-tapping joint, and the damage consequences are shown in figure 13. When the charge is 300 g and the detonation distance is 5 m, the structural change is not obvious compared with the test of 200 g. When the charge is 600 g and the explosion distance is 4 m, the longitudinal span of the steel plate and the contact part of the purlin are obviously deformed, the damage mode is the same as that of the unreinforced color steel plate, and the steel plate and purlin are not torn at the self-tap connection, verifying the effectiveness of the polyure-reinforced color steel plate, and the steel plate surface is not broken by the broken stone, as shown in figure 14. The displacement time-history curve of steel plate under each working condition is shown in figure 15. According to the displacement time-history curve, double-sided spraying polyurea color steel plate has the smallest displacement, and the explosion-proof effect is slightly better than that of spraying polyurea on the back explosion surface, while the explosion-proof effect of spraying polyurea on the front explosion surface is the worst.

Fig. 12. Damage consequence of 100 g explosive 1mm polyurea steel plate

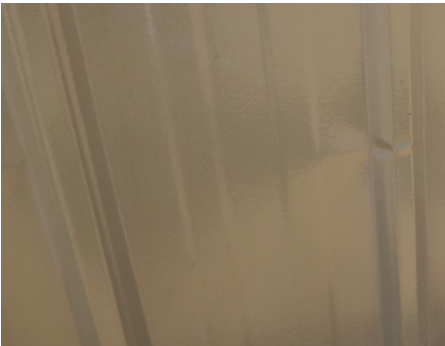
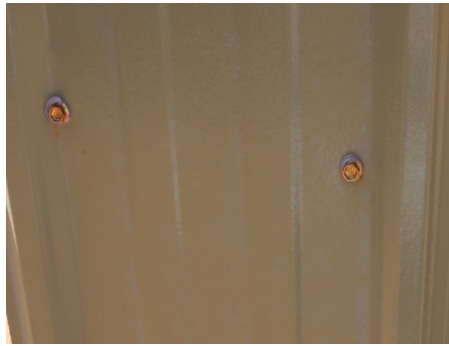
Fig. 13. Damage consequence of 200 g explosive 1mm polyurea steel plate

(a) The steel plate is damaged in the longitudinal span

(b) Purlin contact damaged

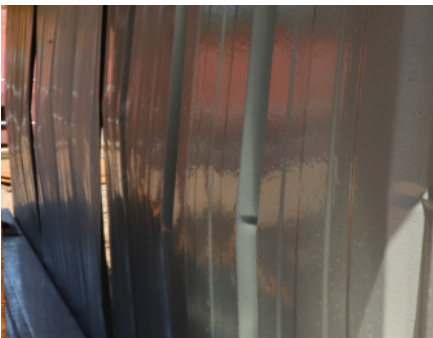
Fig. 14. Damage consequence of 600 g explosive 1mm polyurea steel plate

(a) The steel plate is damaged in the longitudinal span

(b) Purlin contact damaged

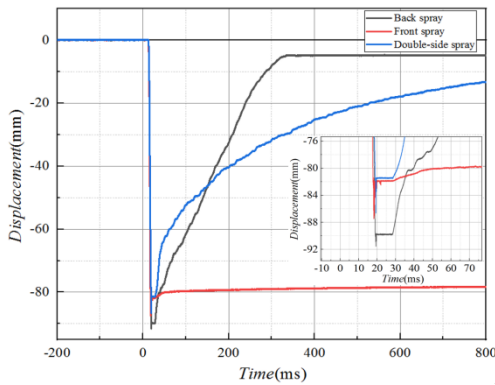
Fig. 15. Displacement time history curve of 1 mm polyurea steel plate

(a) 100g explosive action 1 mm polyurea steel plate displacement

(b) 200g explosive action 1 mm polyurea steel plate displacement

(c) 600g explosive action 1 mm polyurea plate displacement

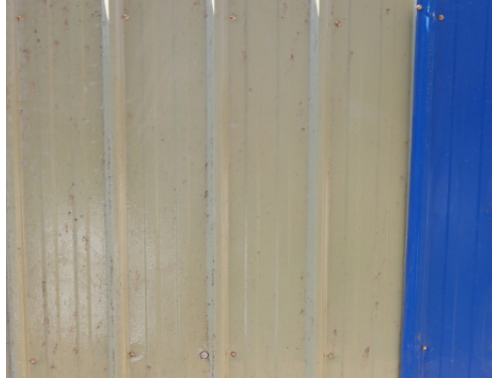
When the charge is 100 g and 200 g explosion distance is 5 m, the color steel plate span and purlin contact parts are not significantly deformed, not with purlin contact parts are not found obvious deformation, steel plate and purlin self-tapping joint deformation is not obvious, as shown in figure 16. When the charge is 300 g and the detonation distance is 5 m, the structure is slightly deformed, and the deformation is mainly concentrated in the longitudinal span of the color steel plate and the connection of the self-tapping, and the depression deformation occurs. When the charge is 600 g and the explosion distance is 4 m, the longitudinal span of the steel plate and the contact part of the purlin are obviously deformed, the damage mode is the same as that of the unreinforced color steel plate and 1 mm polyurea reinforced color steel plate, but the deformation degree is lower than the previous two, and the steel plate and purlin self-taping joint does not tear, further verifies the effectiveness of the polyurea reinforced color steel plate. The surface of the steel plate is not broken by the broken stone, as shown in

Fig. 16. Damage consequence of 200 g explosive 2 mm polyurea steel plate

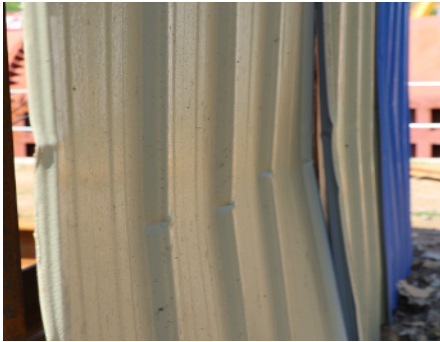
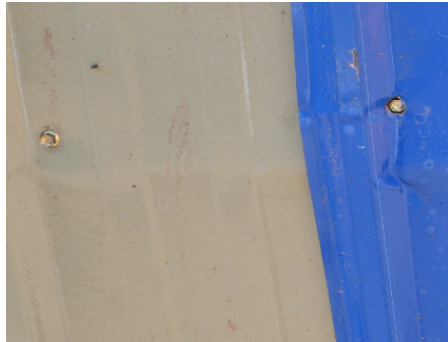
Fig. 17. Damage consequence of 600 g explosive 2 mm polyurea steel plate

figure 17, and the displacement time-history curve of the steel plate under various working conditions is shown in figure 18. According to the displacement time-history curve, the displacement of the polyurea color steel plate on the back explosive surface is not much different from that of the double-side spraying polyurea color steel plate, but the displacement deformation is smaller than that of the single-side spraying of the blasting surface, and the explosion-proof effect of the single-side spraying of the blasting surface is the worst.

(a) The steel plate is damaged in the longitudinal span

(b) Purlin contact damaged
