Analysis and Study on the Effect of Exploration and Treatment on the Ground Area of Limestone Water Damage in Underground Roadway Floor

Keywords: Pan'er Mine; A coal group; exploration and treatment; effect analysis

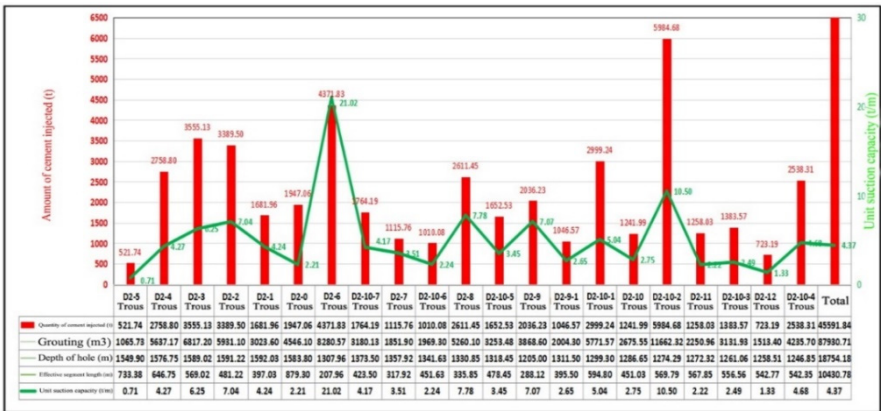
Fig. 2. Grouting quantity diagram of D2 hole group

The project involved drilling and grouting in 31 branch holes across 2 hole groups, with an effective drilling length of 17,325.44 meters and 58,369 tons of cement injected, resulting in a unit grout consumption of 3.37 t/m. Details are shown in Figures 2 and Figures 3.

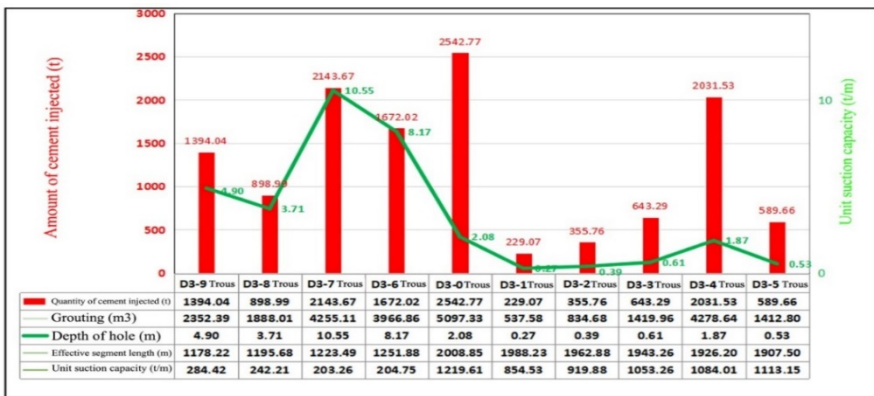
Fig. 3. Grouting quantity diagram of D3 hole group
