# Effect of deformation temperature on microstructure in coating of galvanized hot-formed steel

Zinc-based coating hot forming steel has good cathodic protection characteristics, which makes up for the deficiency of corrosion resistance of aluminum-silicon coating products. However, in the process of hot forming, due to the existence of high temperature liquid zinc, it is easy to cause the problem of liquid metal embrittlement, which limits the market promotion and application of the steel. In this paper, based on Gleeble 3800 thermal simulation testing machine, the matrix structure and coating structure of hot-dip galvanized hot forming steel at different deformation temperatures were characterized and analyzed by metallographic observation and scanning electron microscope. The effects of deformation temperature on the matrix structure, surface oxide and coating structure of hot-dip galvanized hot-formed steel were studied. Combined with the analysis results, the door anti-collision rod was trial-produced using galvanized hot-formed steel. The results show that the content of martensite in the matrix increases with the increase of deformation temperature. When the deformation tem

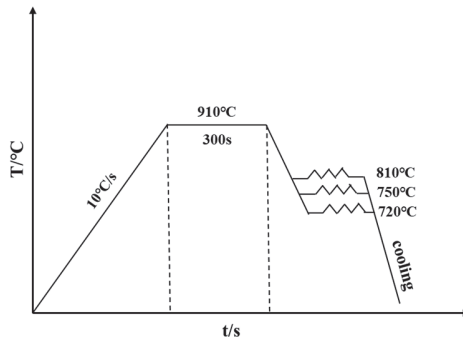
Fig.1. The schematic diagram of temperature system for simulating hot stamping process.

The hot stamping process of galvanized 22MnB5 steel was simulated by Gleeble 3800, and the sample temperature was detected by K-type thermocouple welded in the center of the sample surface. The simulated process system is shown in Fig. 1. The sample was heated to 910°C at 10°C/s and held at this temperature for 300s, and then cooled to 720°C, 750°C, and 810°C to deform to a true strain of 0.25 at a strain rate of 0.1s<sup>-1</sup>. The sample is then immediately quenched to room temperature with compressed nitrogen. The longitudinal section of the uniform temperature zone of the sample was taken for subsequent analysis, and the sample was inlaid, ground and polished. The microstructure of the sample matrix was etched with 4% nitric acid alcohol solution, and the etching time was about 5s. The structure and composition of the coating were analyzed by ZEISS ULTRA55 field emission scanning electron microscope.

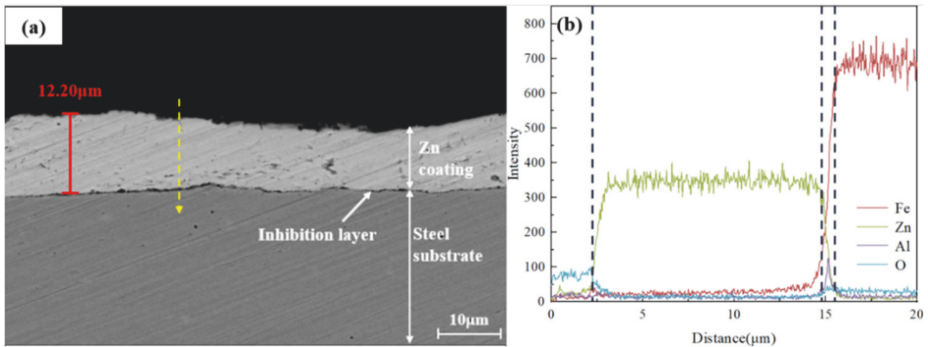
Fig.3. (a)The coating morphology and (b) line scan results of the original plate.

Fig.2 is the matrix structure of the cold rolled sheet, which is composed of ferrite and pearlite. The coating microstructure and EDS results of galvanized hot forming steel sheet are shown in Fig.3. The original coating thickness of galvanized 22MnB5 steel plate is about 12.2 μm, which is composed of pure zinc and interface inhibition layer Fe<sub>2</sub>Al<sub>5</sub>. In order to inhibit the violent reaction between Fe and Zn, a certain amount of Al is added to the zinc pot to preferentially react with Fe to form Fe<sub>2</sub>Al<sub>5</sub> interface inhibition layer, and the inhibition layer at the interface between the substrate and the coating is continuously distributed.

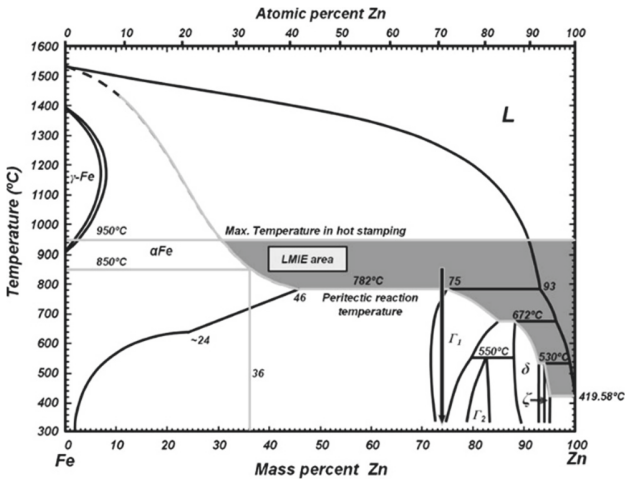
Fig.7. Fe-Zn phase diagram.

According to the Fe-Zn binary phase diagram shown in Fig.7,<sup>[15]</sup> the gray area is the area where the LMIE crack is generated. When stamping at 810°C, the Zn content in  $\Gamma$ -Fe<sub>3</sub>Zn<sub>10</sub> phase is 88.48%, and the deformation temperature is higher than the temperature of peritectic transformation  $\alpha$ -Fe(Zn) +  $\Gamma$ -Fe<sub>3</sub>Zn<sub>10</sub>  $\rightarrow$   $\alpha$ -Fe(Zn) + Zn<sub>liq</sub>. Therefore, during the hot deformation process, part of  $\Gamma$ -Fe<sub>3</sub>Zn<sub>10</sub> is transformed into liquid Zn, resulting in the coating composed of  $\alpha$ -Fe(Zn) and liquid Zn. The presence of liquid phase brittles the  $\alpha$ -Fe ( Zn ) grain boundary. When tensile stress is applied, LMIE cracking is easy to occur at the solid-liquid interface, and liquid Zn continues to diffuse along the  $\alpha$ -Fe ( Zn ) grain boundary to the austenite grain boundary of the matrix. As the deformation progresses, macroscopic cracks are formed in the steel matrix. When deformed at 720 °C and 750 °C, the temperature is lower than the peritectic transition temperature, and only microcracks are generated in the coating.
