Construction of deep plastic concrete cut-off wall in upstream coffer dam of Punatsangchhu-I Hydropower Project, Bhutan

PK Gajbhiye
Geological Survey of India
Pune, India
pkgajbhiye@yahoo.com

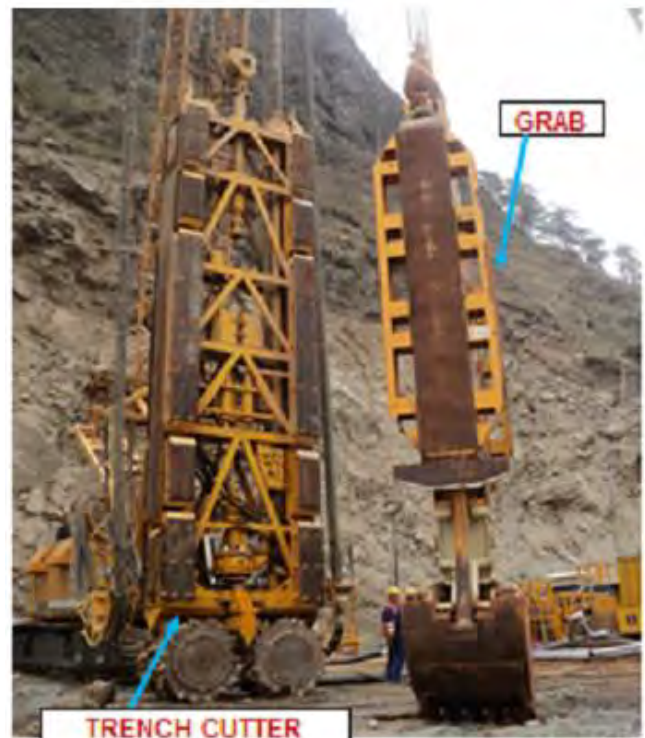
Fig. 3. A view of hydraulic trench cutter and grab

A view of the grab & trench cutter is shown in Fig. 3 and general view of COW excavation operation in Fig. 4.

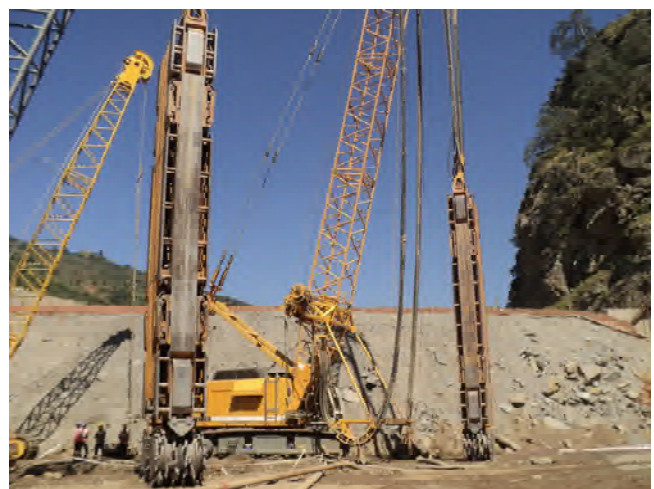
Fig. 4. A view of COW excavation operation

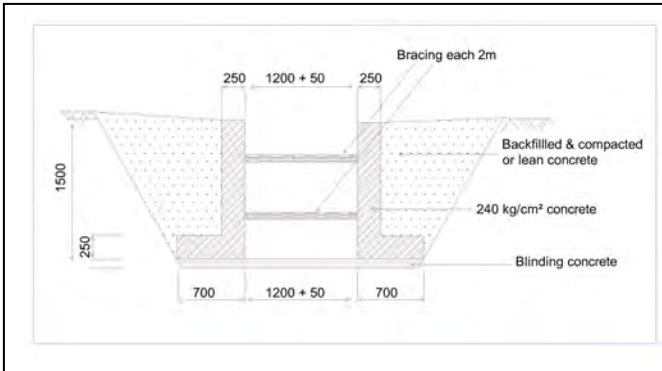
Fig.5. A typical L-shape section of guide wall

- Guidance to ensure the correct alignment of the COW.
- Protection against instability of the top soil zone of the trench caused by fluctuating bentonite levels and agitation of the slurry during excavation.
- Support for the trench stability at the top zone, affected by the vertical surcharge weight of the trench cutter and other heavy jobsite machineries adjacent to the trench.

casting concrete in neighbour panels. Fig.5 shows typical L-shape section of guide wall and Fig.6 shows the view of guide walls and wooden bracings.

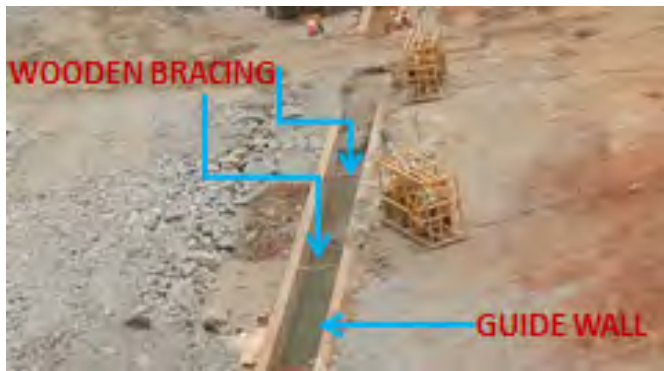
Fig.6. A view of guide wall with wooden bracings

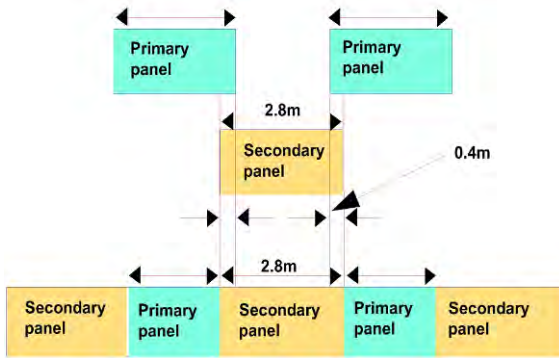
Fig.7. Layout plan of primary and secondary panels of COW

After completion of excavation for panels the plastic concrete was pumped into the trench with pressure. As the concrete level rises during placement in the trench, the excess bentonite is drawn off and pumped to the plant station for re use [1]. After construction of a couple of primary panels, the intermediate secondary panels were excavated. The secondary panels were excavated by cutting in between two adjacent primary panels with 40cm overlapping with side panels, thus having total length of each secondary panel as 2.8m. For this purpose the BC 40 trench cutter with its frame width of 2.8 m was used, which cut into the plastic concrete of the two adjacent primary panels resulting in a rough grooved surface in the cast primary panel further ensuring a higher quality joint between panels. Fig. 7 shows the layout plan of primary and secondary panels of COW

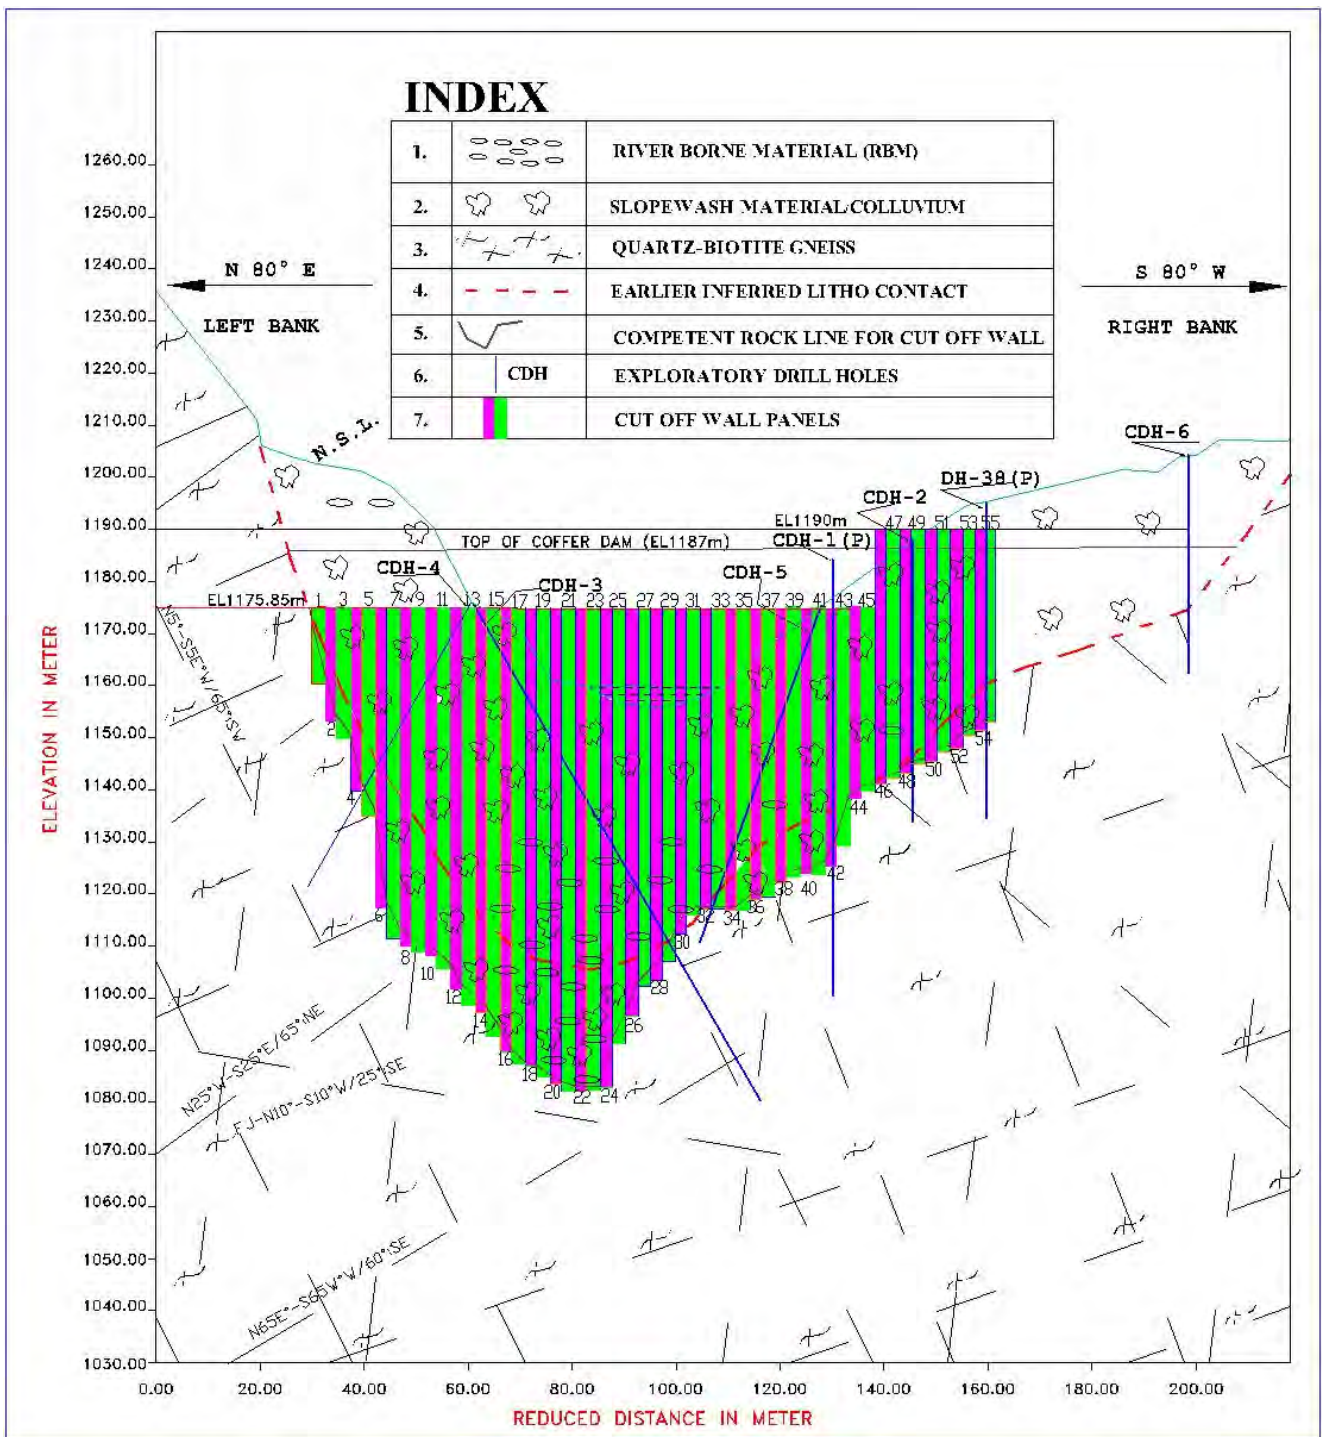
Fig.8 Showing COW Panels and inferred and actual fresh rock profiles

During actual excavation of the COW, the bed rock profile as inferred from exploratory drilling and the actual foundation grade rock profile obtained after excavation of panels, varied to certain extent. Both the profiles did not show much difference on the right bank but it varied to great extent in the center and on left bank due to occurrence of sheared material

The author co-related both the profiles and tried to find the reasons for such variation. Based on the correlation and the collected rock samples at de-sander, it was found that the difference in actual depths of bed rock in both the profiles may not be much, but due to occurrence of shear zone at depth in the center of the valley the trenching/cutting was done up to acceptable foundation grade rock. The difference was due to presence of shear zone dipping gently towards valley, which was missed during stage-I drilling because of wider spacing crated at depth between drill holes CDH-3 and CDH-4 due to their opposite and comparatively gentler inclinations. Steeper inclination (> 70°) of CDH-3 could have given the better profile. It was missed as drill holes being the point data but

was confirmed during the actual excavation for Table III gives the summary of actual depths achieved in each panel of COW and Fig. 8 shows COW panels and inferred bed rock & foundation grade rock profiles.
