## **Deterioration Factor analysis of Composite Insulators based on Experiment and Mathematical Statistics**

**Abstract.** The electrical performance and mechanical properties of nearly 200 composite insulators operating in the power grid for over 5 years are tested, to grasp the current running state of composite insulators, While statistical analysis of their regional type, age, process and so on, the correlation between the degradation of the composite insulators and the boundary conditions is obtained by means of experimental results and statistical methods.

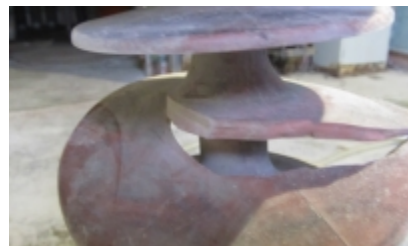
The surface of the majority sampling insulators is good, and there are some problems in the damage and brittleness of the minor umbrella skirt. There are in all 8 insulators existing appearance problems, among them, there are two insulators service times between 5 and 8 years, four insulators service time between 8 and 15 years, two insulators service times more than 15 years, there is no significant correlation between the tearing of umbrella group and the contamination test, from the destruction appearance, the insulator umbrella skirt damage within 8 years is mainly caused by mechanical force, such as construction stampede, transport extrusion, etc., which does not belong to the normal deterioration defects, and more than 15 years, from the cross-section and umbrella skirt which is brittle and hardness, it is caused by deterioration.

Fig.1 Damage and brittleness of insulator umbrella skirt

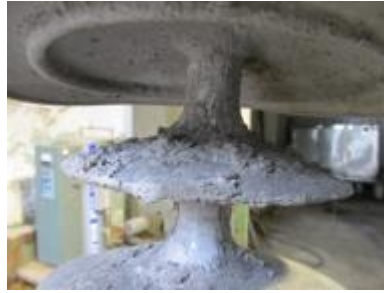
Measurement results of salt density of composite insulators are between 0.09mg/cm<sup>2</sup> and 0.48mg/cm<sup>2</sup>. Part of the insulator pollution is very serious, most of the area is covered by cement scaling, as is shown in figure 2. And it is found that the insulator at long service is obvious slightly higher in whole pollution grade than the insulator at short service.

Fig.2 Insulator contamination situation

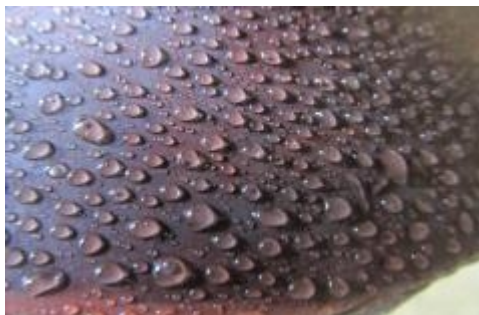
a) Good hydrophobicity

Fig.3 Hydrophobicity of insulators

From the test results, the areas located in severe cement, fused magnesium dust pollution, the hydrophobicity of umbrella skirt is decline more obvious than it in the coastal area , lower 1-2 level. The sampling insulation surface hydrophobic distribution of the voltage level is between HC2 and HC5.

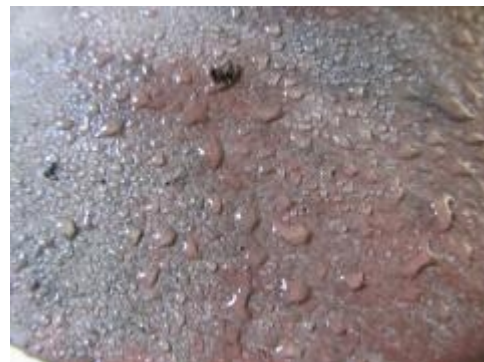
b) Poor hydrophobicity

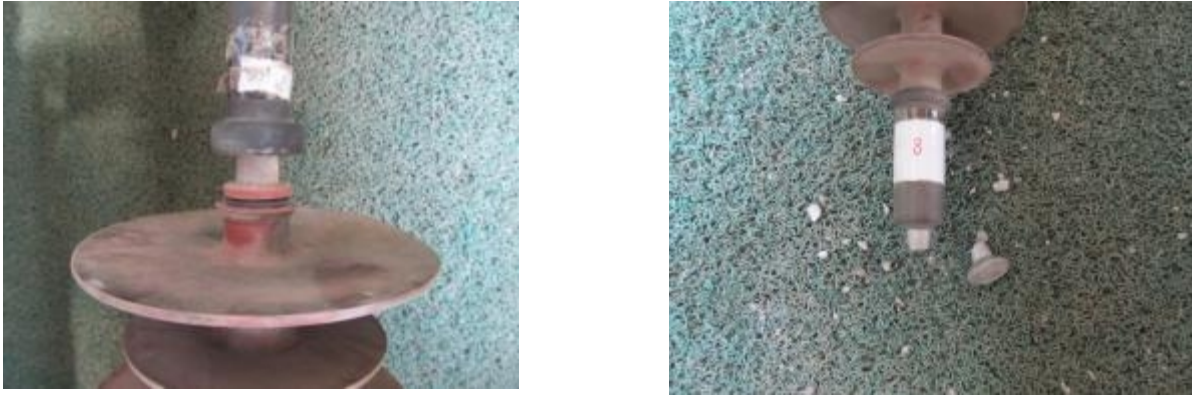
From the operation data and tests, it is found that some gold and mandrel of manufacturers with the wedge crimp structure insulator, which is less than the rated tensile fracture situation, it reflects close relation between the structure and mechanical load .

Fig.4 Mechanical disruption of insulators
